# TREE ASSESSMENT

S22675 Renewal Sa Gilles Plains Tafe Site

Wednesday, 17 April 2019

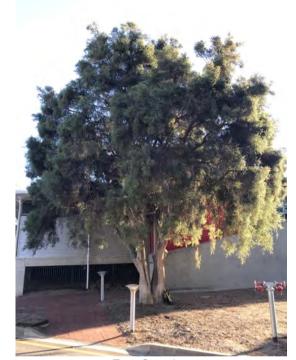
## Botanical Name: Melaleuca linariifolia - Narrow Leaf Paperbark

Good Shape And Form Melaleuca. Tree Worthy Of Retaining. Prune Failed Limbs Caught In Canopy. Remove Deadwood.

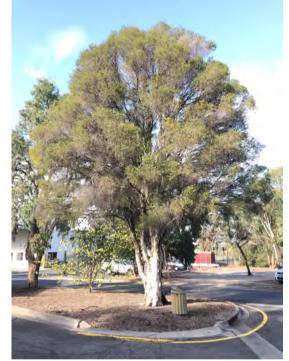
# Appendix A: Tree Schedule Botanical Name: Melaleuca styphelioides - Prickly Paperbark

No Works. Tree In Good Health And Form. Worthy Of Retaining. Low Hazard Tree.

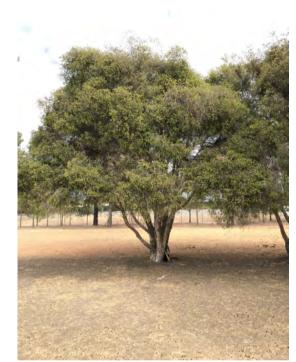
# Appendix A: Tree Schedule Botanical Name: Melaleuca styphelioides - Prickly Paperbark

No Pruning Required. Large Trunk Section For Small Tree. Low Hazard Tree Worthy Of Retaining.

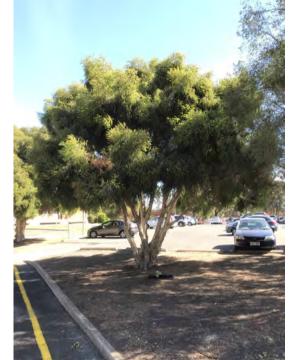
Good Shape And Form. Tree Falls Just Into Regulated With Average Stem Circumference. Low Hazard Species Worthy Of Retaining.

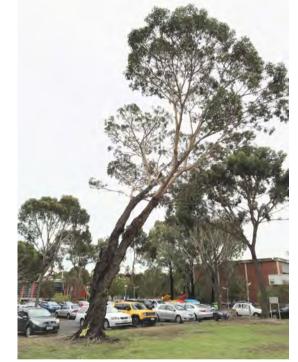
# Appendix A: Tree Schedule Botanical Name: Eucalyptus occidentalis - Flat-topped Yate

Tree Showing Good Canopy Health Considering Main Central Stem Has Been Removed Due To Upper Canopy Decline. The North Eastern Leader Has A Fair Size Cavity In The Upper Surface Of The Limb. The Extending Canopy Above Has The Potential To Fail From This Point Due To The Heavy Weight It Supports. Swelling Has Occurred In Response Growth To Region. The Main Northern Remaining Scaffold Has Large Wounds Below Attachment And Cambium Loss From Pest Attack Surrounding The Removed Central Stem.

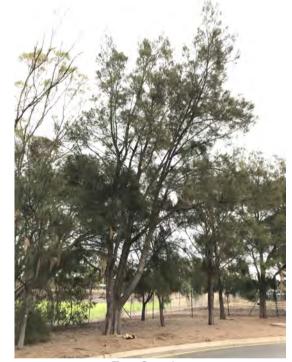
## Botanical Name: Casuarina cunninghamiana - River Oak

Remove Failed Limb From Canopy. Good Health Worthy Of Retaining.

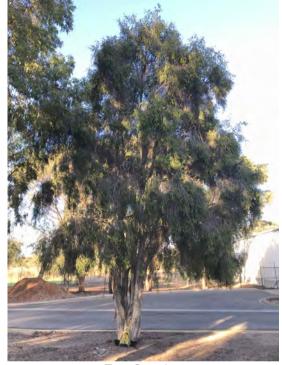
# Appendix A: Tree Schedule Botanical Name: Melaleuca styphelioides - Prickly Paperbark

Multi Stemmed Melaleuca. Good Health. Worthy Of Retaining. Low Hazard Tee.

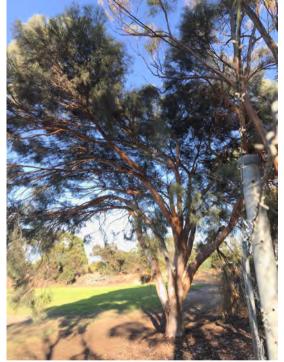
# Appendix A: Tree Schedule Botanical Name: Eucalyptus spathulata - Swamp Mallet

Tree In Good Health Shape And Form. Worthy Of Retaining.

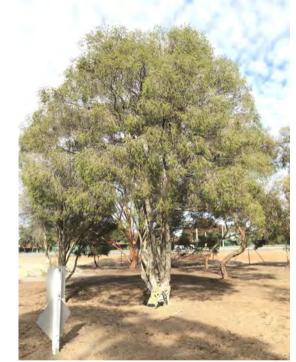
# Appendix A: Tree Schedule Botanical Name: Melaleuca styphelioides - Prickly Paperbark

No Works Required. Good Shape And Form. Low Hazard Tree. Worthy Of Retaining.

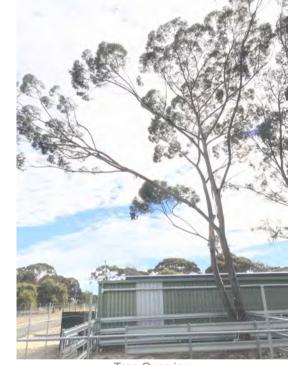
Large Gum. Co Dominant Stems From 1m. Over Extended Lateral. Good Health. Area Around Root Plate Has Been Excavated To Flatten Ground For Live Stock Holding. Roots Severed.

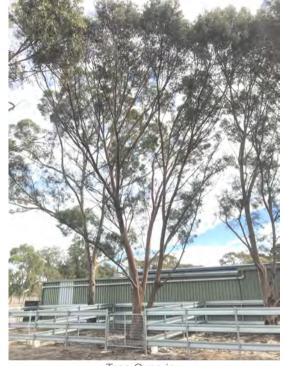
Good Health And Form. Worthy Of Retaining. Surface Roots Severed During Leveling Of Area Around Tree For Live Stock Holding.

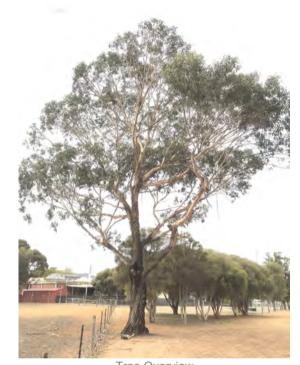
Large Swamp Yate. Tree Has Endured Large Limb Failure At Attachment. Wound Occluding. Tree Shows Good Health.

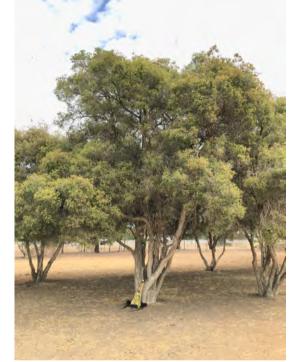
## Botanical Name: Melaleuca linariifolia - Narrow Leaf Paperbark

No Pruning Required. Worthy Of Retaining. Low Hazard Tree. Large Trunk Small Tree.

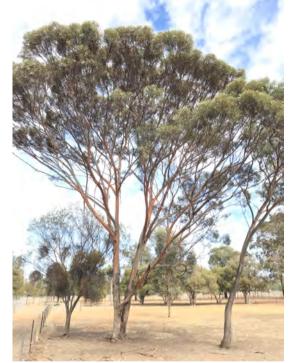
Tree Shows Good Health And Structure. Bifurcated At 1m Forming Co Dominant Stems. Good Union. Girdle Root At Base. Worthy Of Retaining.

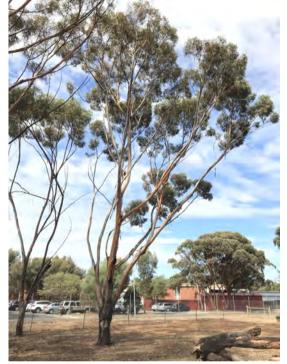
Large Gum In Sheep Paddock. Major Cambium Damage From Live Stock. Good Health.

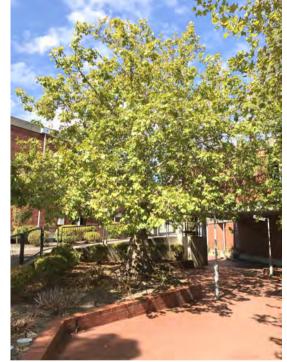
## Appendix A: Tree Schedule Botanical Name: Platanus orientalis - Oriental plane

Large Plane Tree With Low Broad Canopy Form. Large Swelling Basal Flare. Good Health. Tree Worthy Of Retaining. Currently In Good Growing Location. No Work Required.

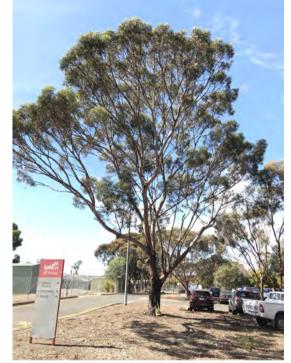
Good Health Shape And Form. Good Occlusion To Trunk Wound. Some Termite Frass Visible On Wound. Worthy Of Retaining.

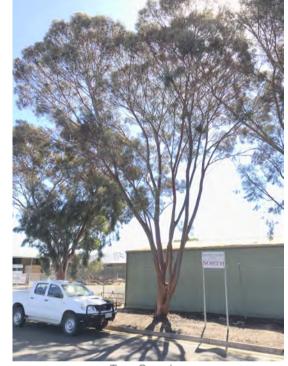
Tree Located In Horse Area. Tree Showing Reasonable Health With Cambium Damage Around Trunk Section. Wound From Large Limb Fail. No Work.

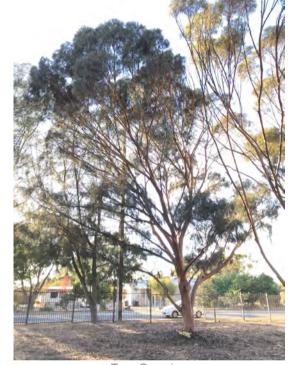
Large Gum With Good Health. Canopy Bias To North. Included Bark In Main Trunk Bifurcation. Appears Stable.

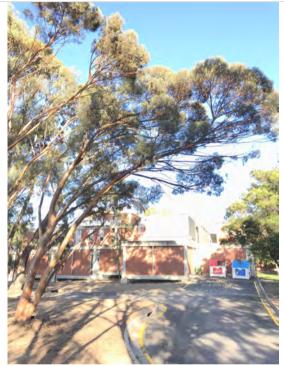
Good Health With Canopy Bias To North East On Moderate Lean. Wounds On Main Stem Occluding Well.

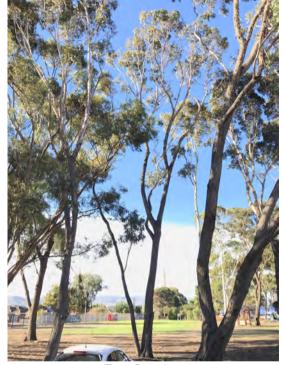
Base Circumference (mm)	2450
Structural Root Zone (m)	2.98185609
1m Circum. Total (mm)	2170
1m Circum. Average. (mm	1085
Legislative Status	Regulated
1.4m Circumference (mm)	2080
Tree Protection Zone (m)	7.94904459
Works Required	
<ul> <li>Reduce To Upright</li> <li>Canopy Reduction - Eastern Side 11- 20%</li> </ul>	
Tall Erect Gum With Split And Failing Basal Stem. Evidence Of Termite Activity. Basal Limb Starting To Split With High Potential For Fail. Remove Basal Stem.

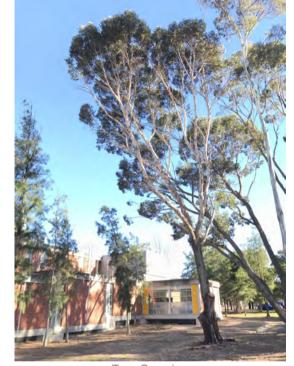
Large Tree With Good Health Considering The Major Pest Attack And Damage To Trunk Cambium. Longicorn Beetle Damage. Tree Has Endured Major Limb Removal Due To Recent Large Limb Failure. Not Worthy Of Retaining.

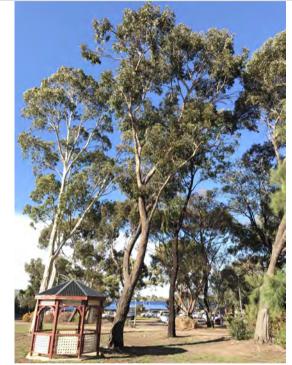
Good Health And Form. Requires Deadwood Pruning In Canopy.
