# Preliminary Site Investigation

Gilles Plains TAFE

Client: Renewal SA

27-Jul-2019

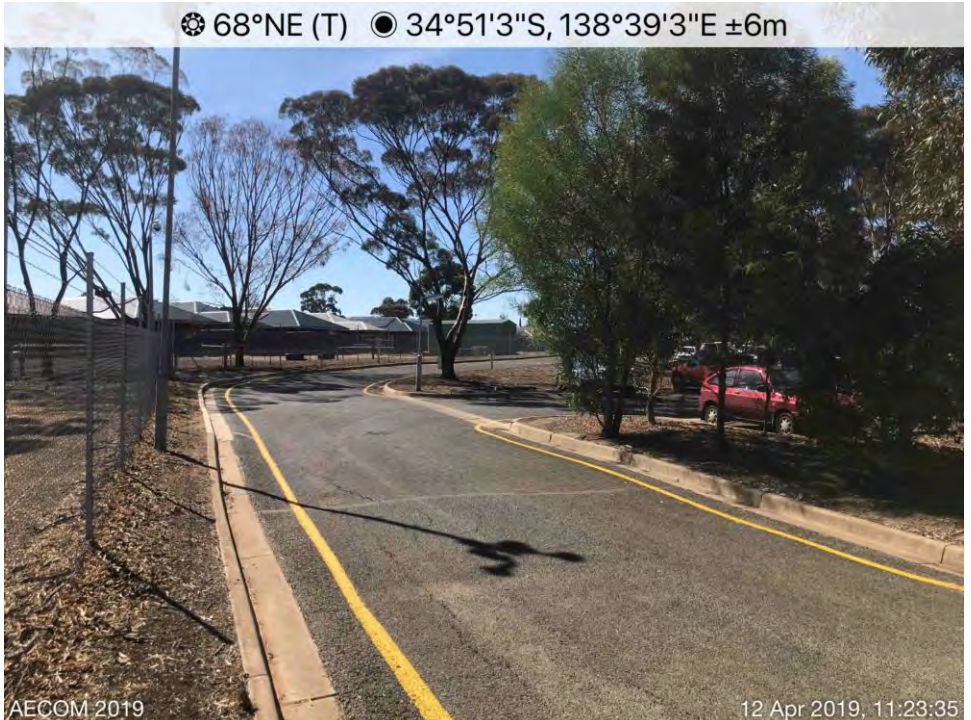
<b>Site Name:</b> Gilles Plains TAFE		<b>Site Location:</b> Blacks Road, Gilles Plains	
<b>Plate No.</b> 3.			
<b>Description:</b> Site northern car park.

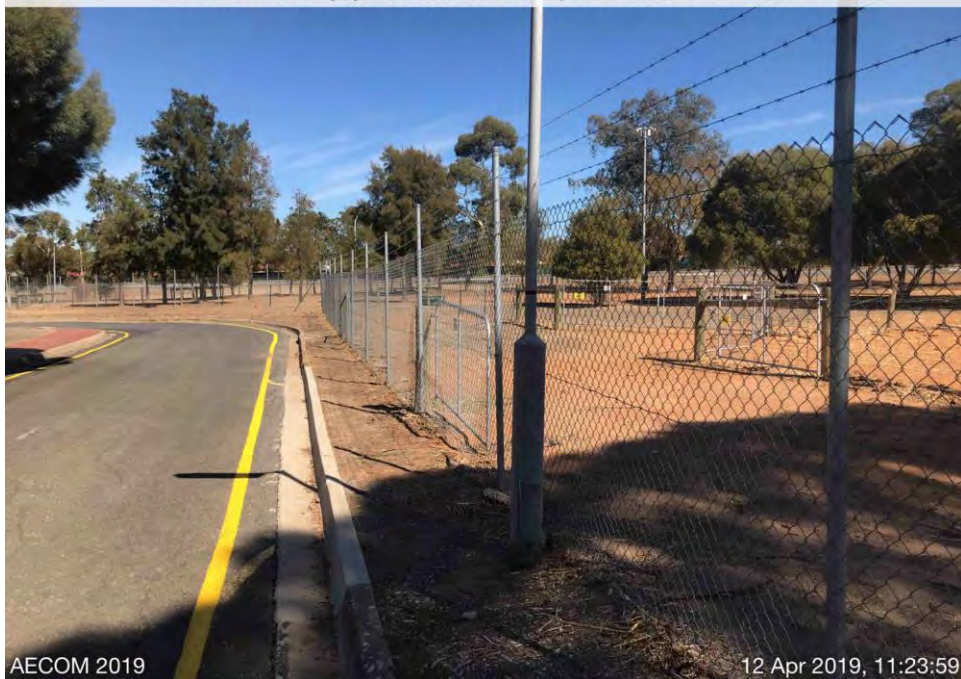
<b>Site Name:</b> Gilles Plains TAFE		<b>Site Location:</b> Blacks Road, Gilles Plains	
<b>Plate No.</b> 6.	<div>☼ 233°SW (T)    ● 34°51'4"S, 138°39'3"E ±6m</div>

<div>AECOM 201912 Apr 2019, 11:23:59</div>		
<b>Description:</b> Site north-west corner to right hand side of photo.  Agricultural pens extending around along site western boundary.

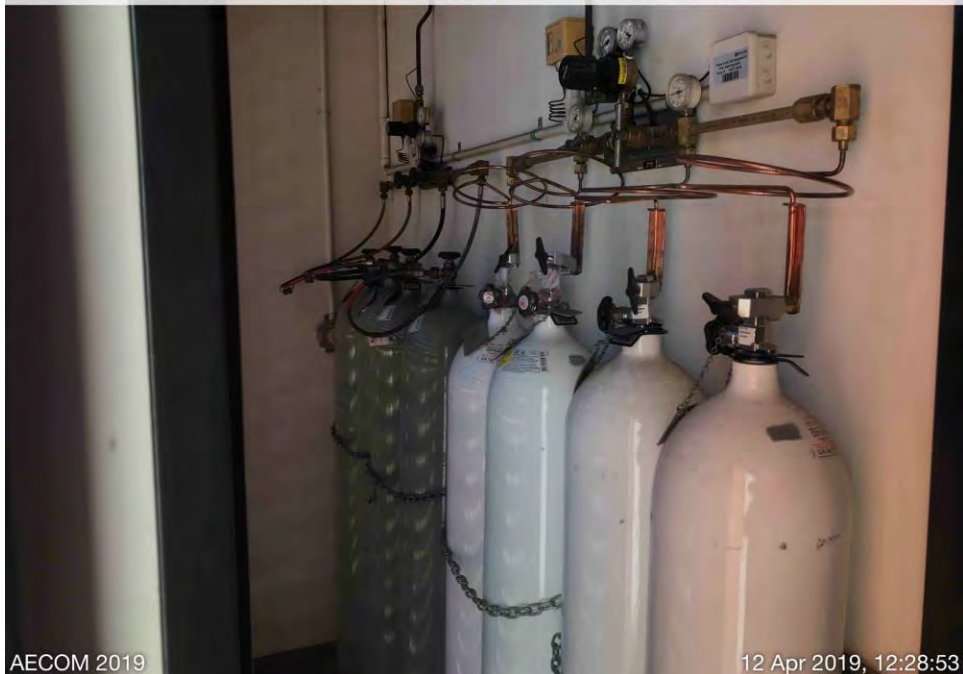
<b>Site Name:</b> Gilles Plains TAFE		<b>Site Location:</b> Blacks Road, Gilles Plains	
<b>Plate No.</b> 14.	<div><div>⊗ 357°N (T)   ● 34°51'7"S, 138°39'5"E ±32m</div>

</div>		
<b>Description:</b> Cylinder store connected to Building 4.

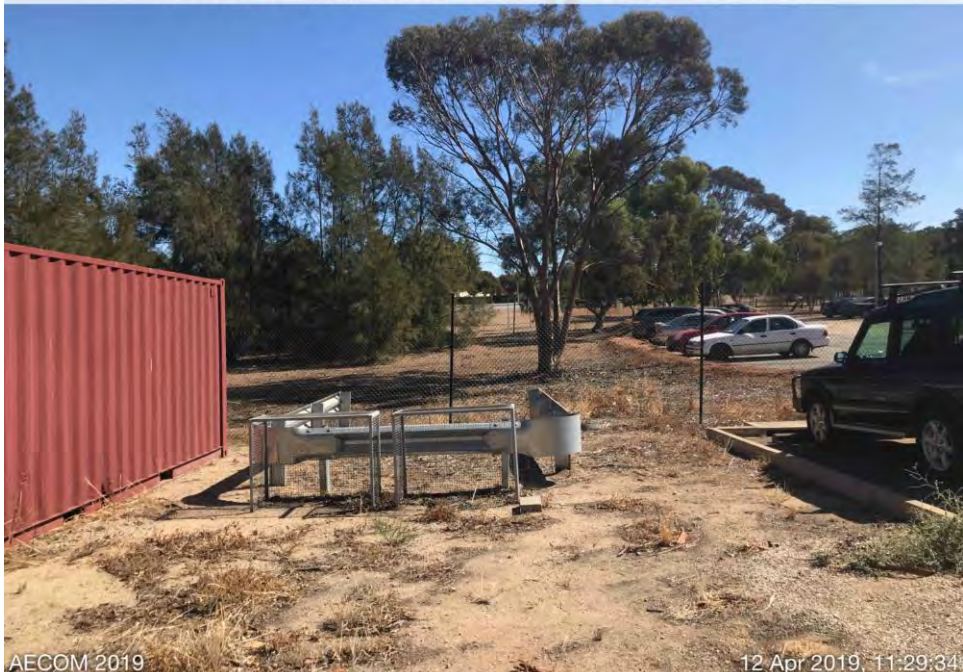
<b>Site Name:</b> Gilles Plains TAFE		<b>Site Location:</b> Blacks Road, Gilles Plains	
<b>Plate No.</b> 22.	<div><div>☼ 305°NW (T)    ● 34°51'10"S, 138°39'3"E ±6m</div>

<div>AECOM 2019<span>12 Apr 2019, 11:29:34</span></div></div>		
<b>Description:</b> Cages and metal barrier within fenced area of Building 10.

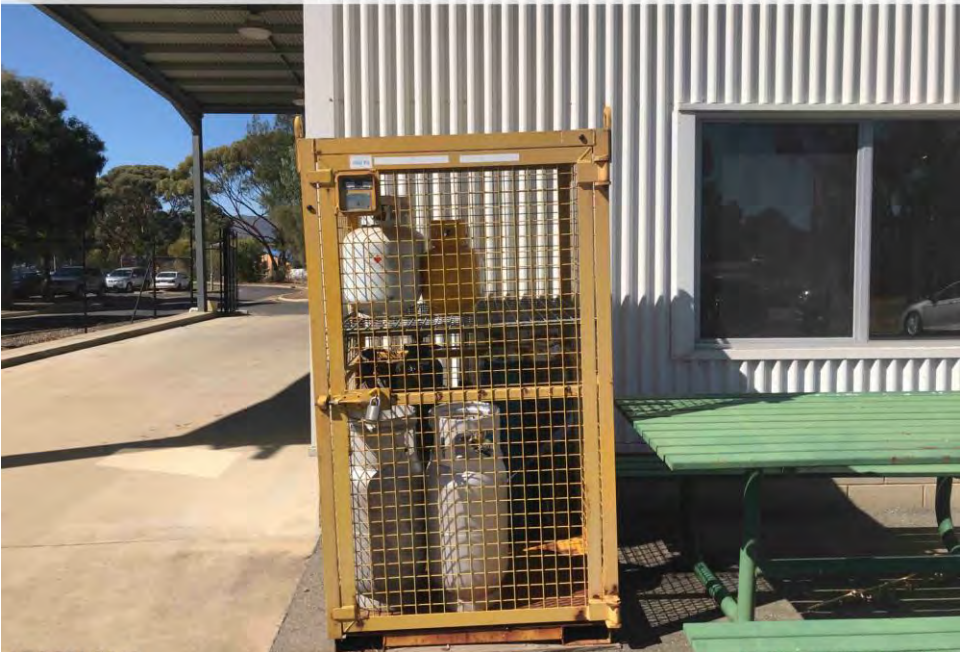
<b>Site Name:</b> Gilles Plains TAFE		<b>Site Location:</b> Blacks Road, Gilles Plains	
<b>Plate No.</b> 23.	<div><div>☼ 130°SE (T)    ● 34°51'9"S, 138°39'4"E ±4m</div>

<div>AECOM 201912 Apr 2019, 11:29:03</div></div>		
<b>Description:</b> Gas cylinder storage outside of Building 10.

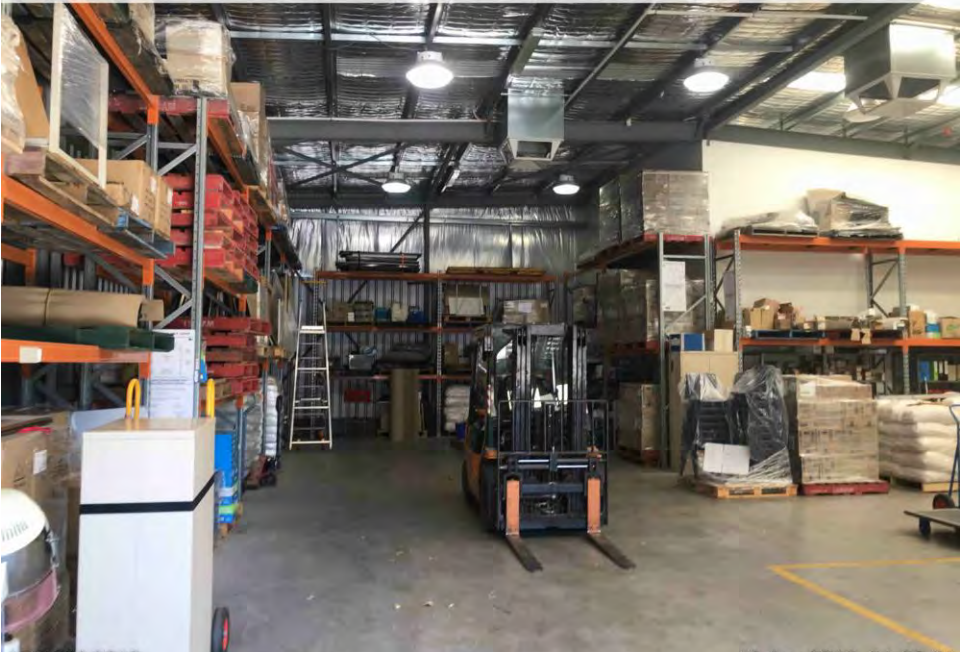
<b>Site Name:</b> Gilles Plains TAFE		<b>Site Location:</b> Blacks Road, Gilles Plains	
<b>Plate No.</b> 24.	<div><div>☼ 158°SE (T)    ● 34°51'9"S, 138°39'5"E ±12m</div>

<div>AECOM 201912 Apr 2019, 11:32:44</div></div>		
<b>Description:</b> Inside Building 10 distribution centre.

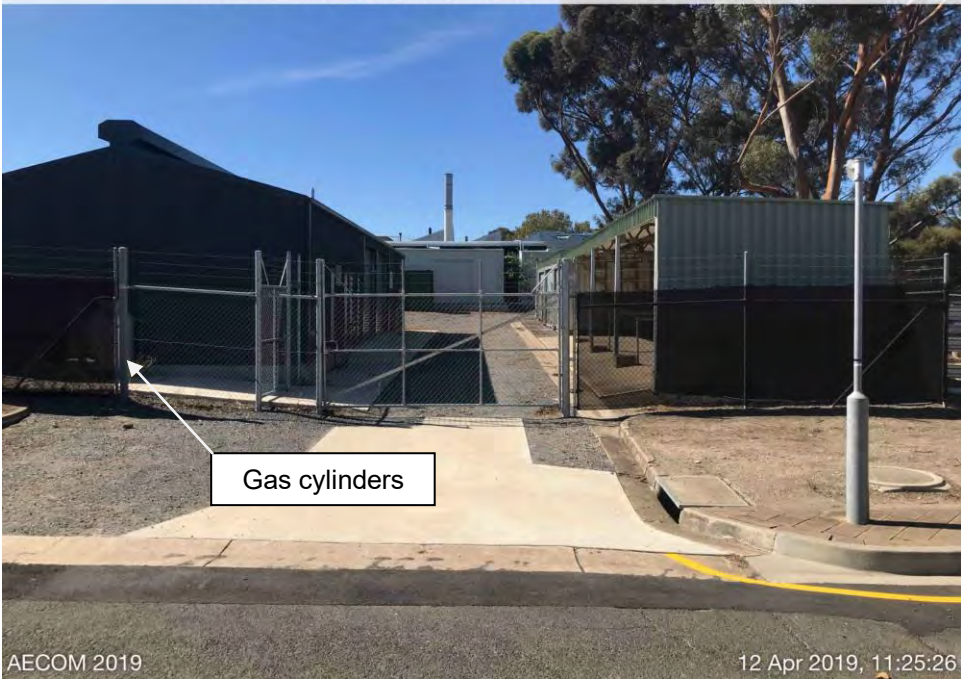
<b>Site Name:</b> Gilles Plains TAFE		<b>Site Location:</b> Blacks Road, Gilles Plains	
<b>Plate No.</b> 27.		92°E (T) 34°51'6"S, 138°39'2"E ±6m	
<b>Description:</b> Gas cylinders located at the rear of shed 12 to the left.

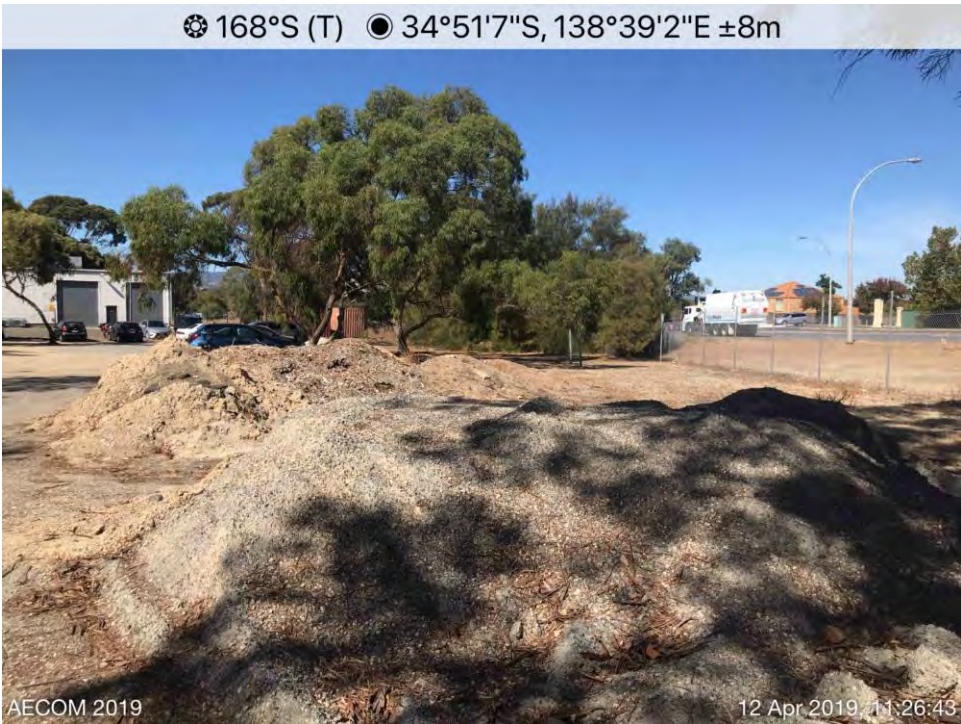
- Stockpiled soil (approximately 128m<sup>3</sup>) was noted in the south-west corner of the site (north-west of Building 10) (**Plate 28**). The stockpiled soil seems of mixed quality and is not consistent with virgin material.
- A kiln / pizza oven is present to the west of Building 4 (**Plate 29**).
- No asbestos warning stickers were noted at the site.

<b>Site Name:</b> Gilles Plains TAFE		<b>Site Location:</b> Blacks Road, Gilles Plains	
<b>Plate No.</b> 28.		168°S (T) 34°51'7"S, 138°39'2"E ±8m	
<b>Description:</b> Stockpiled material to the north west of Building 10.

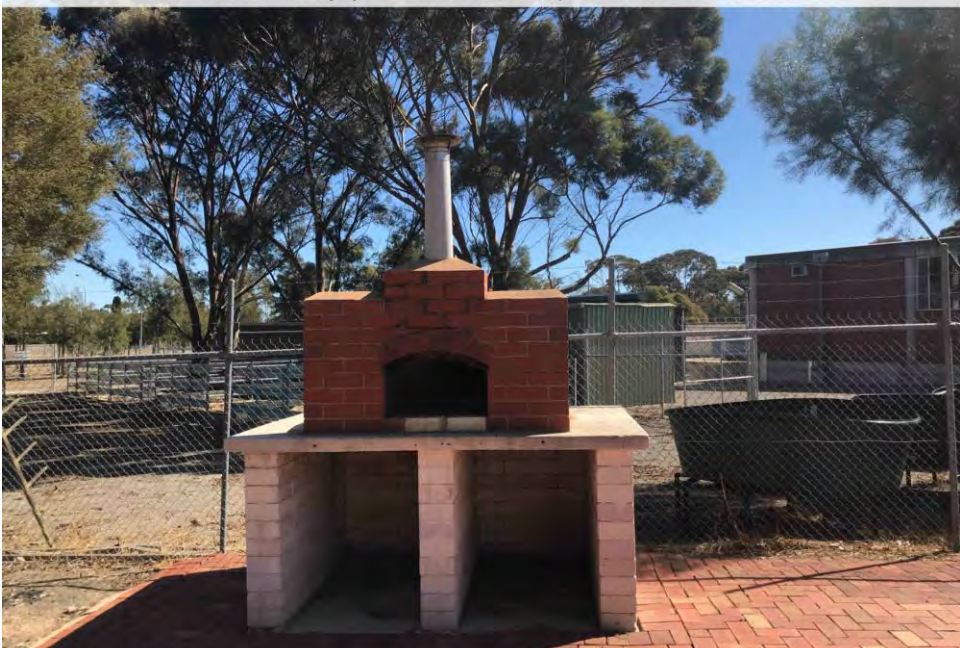
<b>Site Name:</b> Gilles Plains TAFE		<b>Site Location:</b> Blacks Road, Gilles Plains
<b>Plate No.</b> 29.	<div><div><div>☼ 307°NW (T)    ● 34°51'7"S, 138°39'4"E ±6m</div>

<div>AECOM 2019<span>12 Apr 2019, 11:51:26</span></div></div></div>	
<b>Description:</b> Kiln / pizza oven located to the west of bulding 4.
