TREE ASSESSMENT

S22676 Former Oakden Older Persons Mental Health Facility Site

Wednesday, 17 April 2019

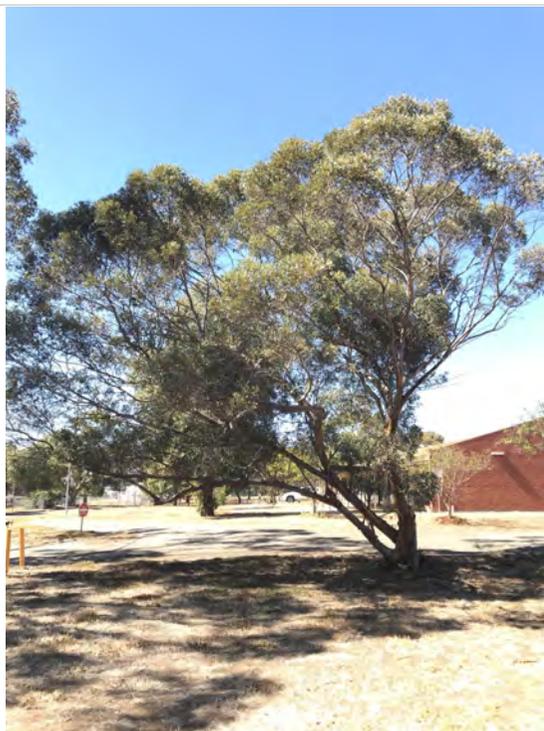
Botanical Name: Eucalyptus gardneri - Blue Mallet

Major Fail Wound On Trunk From Cavity And Included Bark Union. Decaying Heartwood Present At Wound Along With Bracket Fungi At Base Of Trunk Section Below Wound.

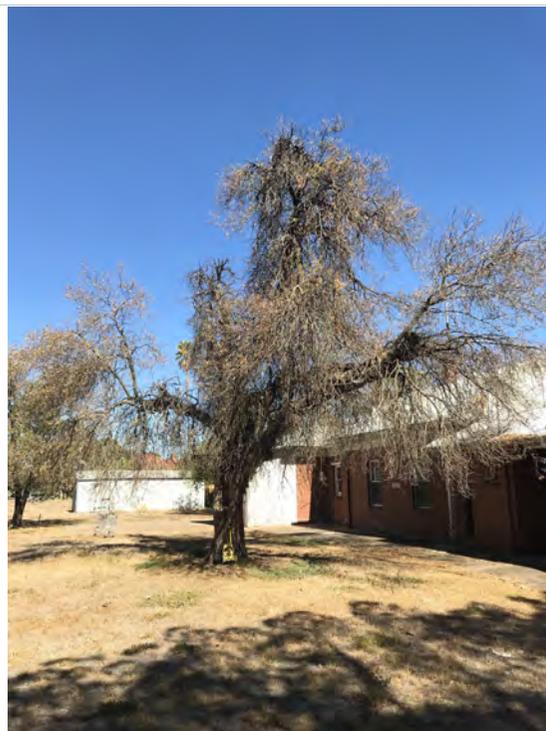
Botanical Name: Fraxinus angustifolia - Desert Ash

Larger Ash Tree In Major Decline. Dead Creeper All Through Tree. Recommend Remove This Tree.

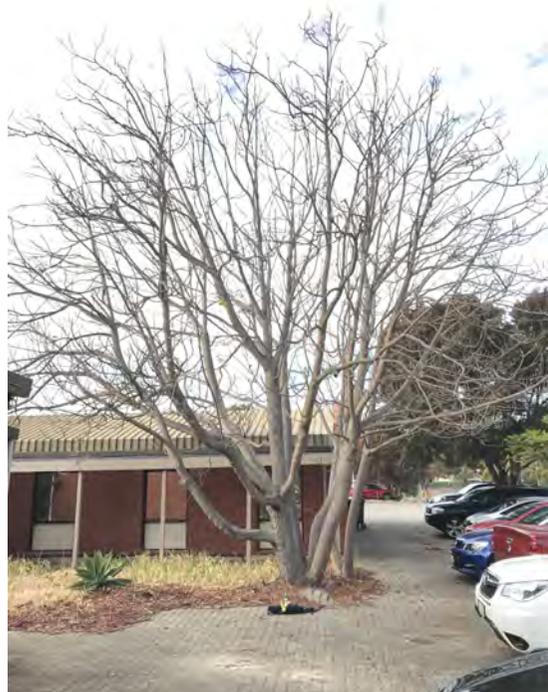
Botanical Name: Ailanthus altissima - Tree of Heaven

Recommend Remove Dead Neem Tree. Grind Stump.

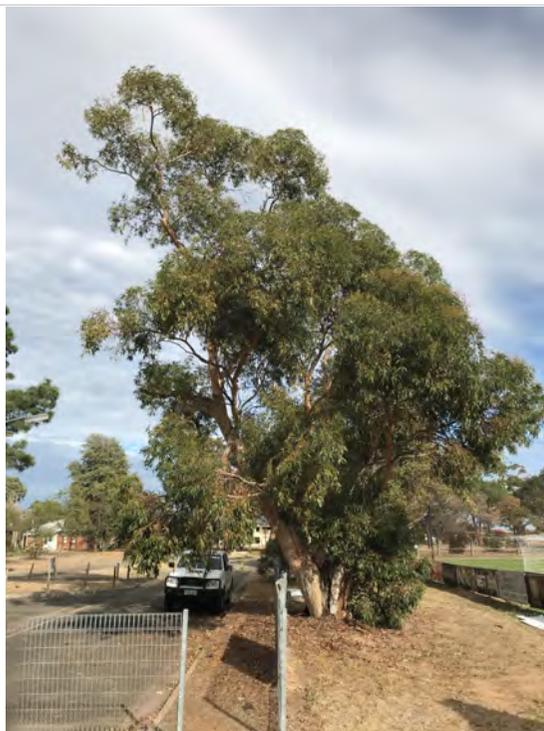
Botanical Name: Eucalyptus cladocalyx - Sugar Gum

Tree Located In Neighbouring Property Close To Fence Line Removal Would Be Recommend If Tree Resided On Sa Renewal Site.
 Tree Has Endured Major Termite Damage And Has Compromised Trunk Section. Bird Damaged Unions.
 Tree Is Regulated And Requires Protection Zone If Construction Required Close To Tree.

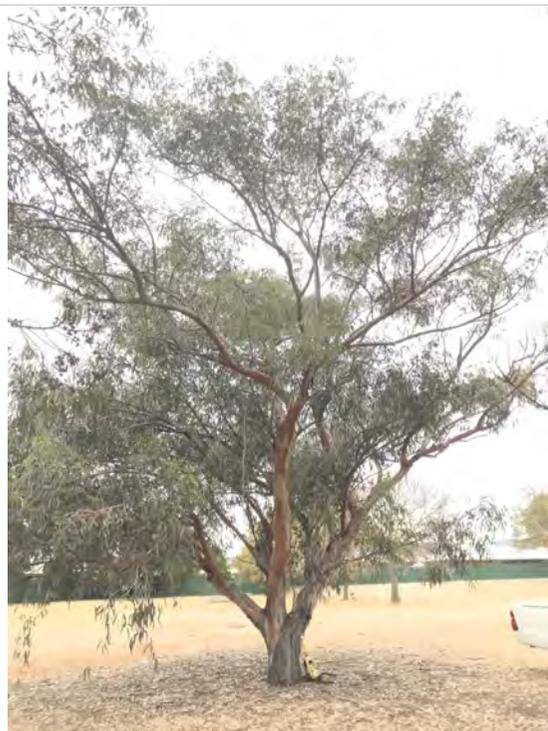
Botanical Name: Eucalyptus stricklandii - Stricklands Blackbutt

Larger Gum Showing Good Health. History Of Limb Fails From Some Time Ago With Good Response Growth. Good Shape And Form For This Species(strickland Black Butt) Although Pruning Could Improve. Remove Deadwood And Prune Stubs To Either Collars Or Developing Growth Points. Lightly Lift Canopy To Desired Height. (adequate Head Clearance) Reduce Lateral Over Extension To Best Points.

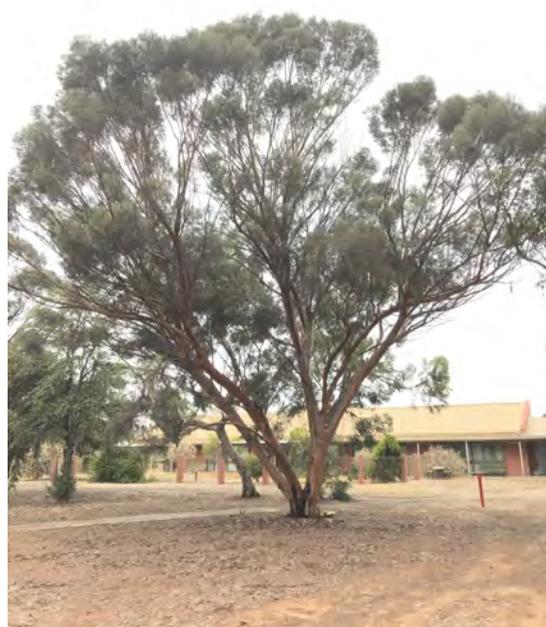
Botanical Name: Eucalyptus spathulata - Swamp Mallet

Good Health. Deadwood Through Out Tree. Several Fails Noted With Stubs Present. Northern Basal Leader Holding Fair End Weight With Extension Just Beyond Main Canopy Line.
Prune Deadwood From Canopy. Reduce Northern Leader By 10-15%.

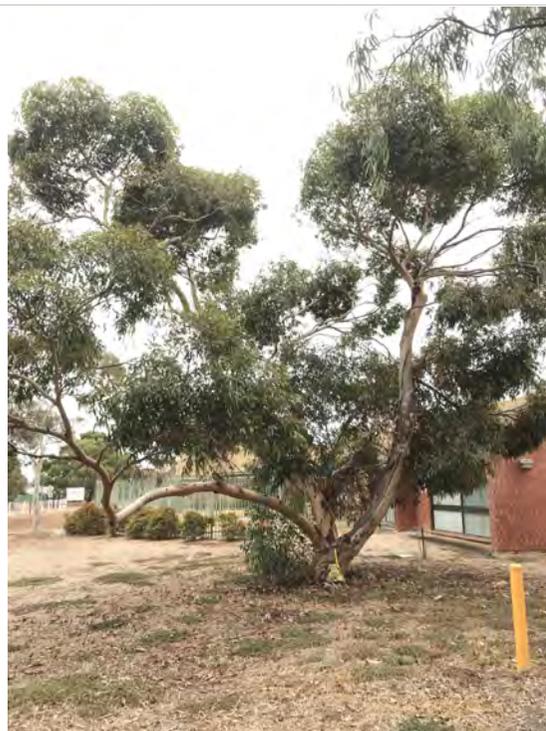
Botanical Name: Eucalyptus cladocalyx - Sugar Gum

Sugar Gum Showing Reasonable Health With Average Structure. Dacayed Stems With Large Cambium Wounds. Recommend Remove Tree.

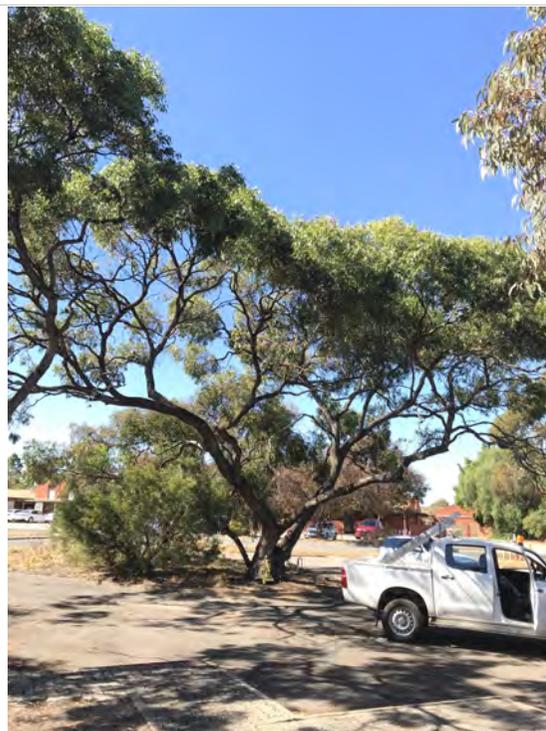
Botanical Name: Eucalyptus odorata - Peppermint Box

Gum Tree Showing Good Shape And Form. Good Canopy Health. Holds Deadwood Through Out Canopy To Remove. This Tree Is Worth Retaining. Native And Local Species To The Region. No Fails Noticed Only Pruning Wounds From Last Limb Pruning.

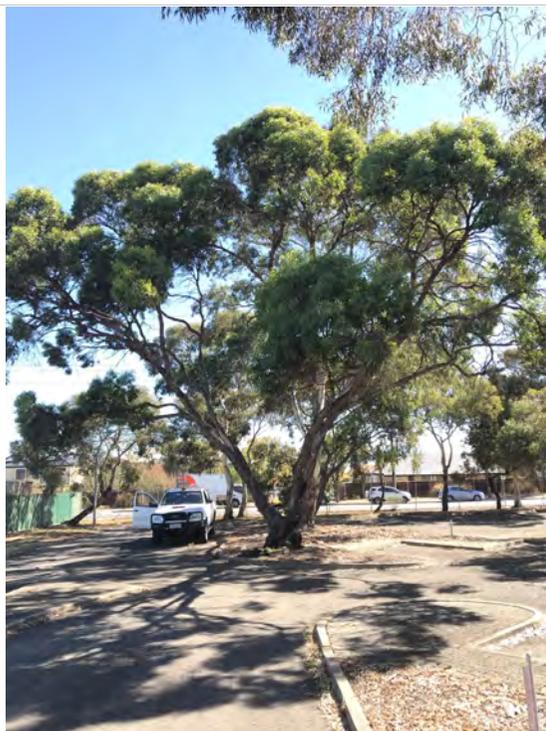
Botanical Name: Eucalyptus odorata - Peppermint Box

Tree Shows Good Structure Shape And Form For Species. Good Canopy Health. Holds Deadwood Through Tree. No Major Defects Noticed. Prune All Major Deadwood From Tree.

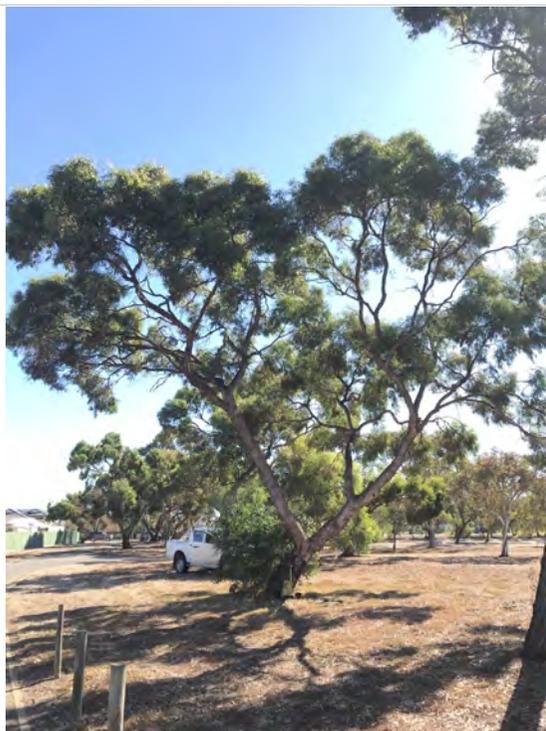
Botanical Name: Eucalyptus odorata - Peppermint Box

Prune All Deadwood From Tree. Shows Good Health And Structure. Worthy Of Retaining. Hard To Replace A Tree Of This Size, Shape And Structure. (would Make A Great Tree For A Back Yard)
Becoming Close To Regulated With A Few More Years Before It Reaches 2m Based On Species Growth.

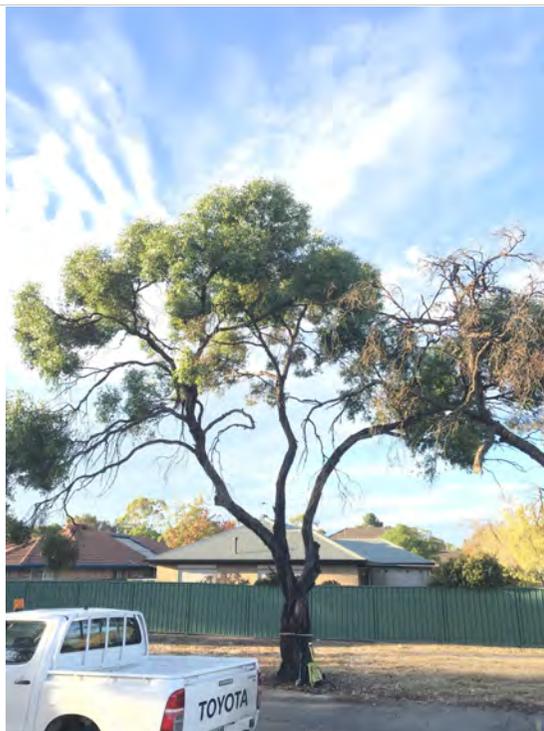
Botanical Name: Eucalyptus odorata - Peppermint Box

Tree Shows Good Health With Reasonable Structure. Wound From Large Limb Fail Showing Good Occlusion. Prune Deadwood From Tree. Lighten Laterals On Western Leader By 10%.

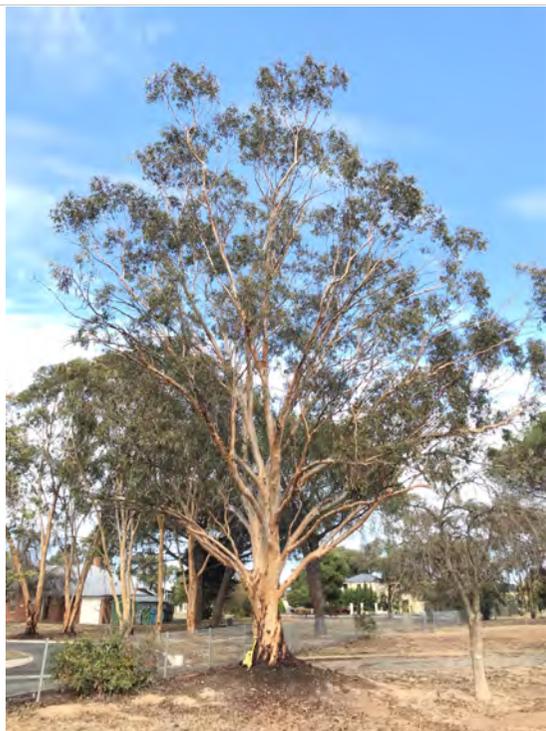
Botanical Name: Eucalyptus sp - Gum Tree

No Pruning. Tree On Out Side Of Property On North, But Close To Fence Line. Located In Oakden Soccer Fields. Consideration Of The Trees Protection Zone Is Required If Construction Is To Occur Close To Tree. Large Raised Root Plate With Mound Around Tree. Showing Good Health. Several Failed Limbs In Canopy With Stubs Present.

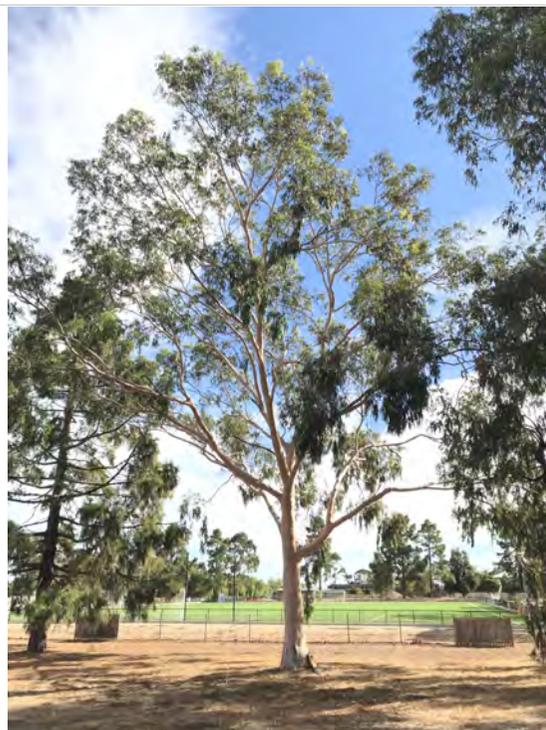
Botanical Name: *Corymbia citriodora* - Lemon Scented Gum

Large Lemon Scented Gum Becoming Close To Regulated In Size. (195cm). Good Health Shape And Form Good Structure And Unions. Prune Deadwood And Stubs From Minor Limb Fails To Collars. Lightly Lift Lower Lateral To East.
