Preliminary Site Investigation

Former Oakden Older Persons Mental Health Facility

Client: Renewal SA

08-May-2019

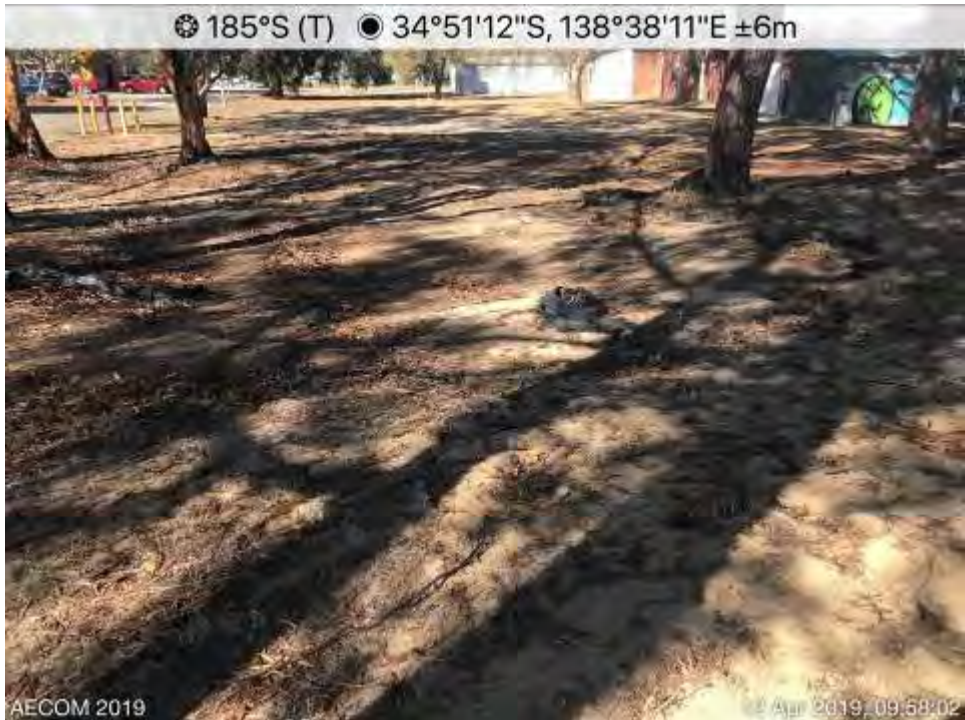
Description: Imported sand fill present in north-west corner of site.

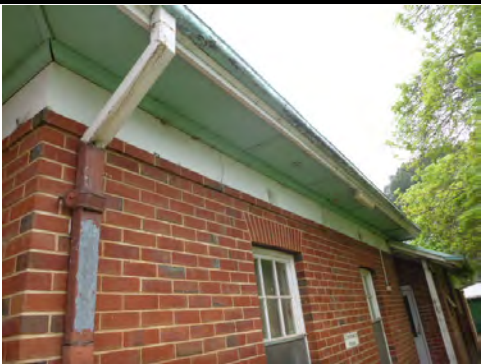
SURVEY FINDINGS and HAZARD MANAGEMENT RECOMMENDATIONS Low Risk P4 – Avoid physical and mechanical damage. When maintenance/upgrade is required, recommend removal and reinstate with non-asbestos product.

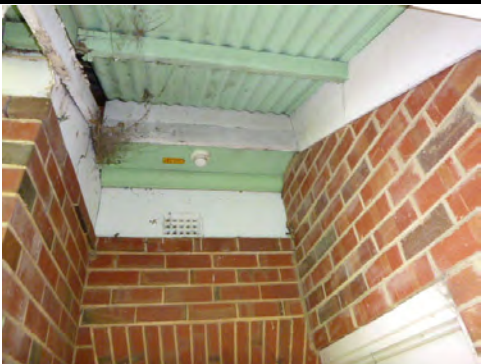
SURVEY FINDINGS and HAZARD MANAGEMENT RECOMMENDATIONS Low Risk P4 – Avoid physical and mechanical damage. When maintenance/upgrade is required, recommend removal and reinstate with non-asbestos product. August 2016 – Paint in poor condition. Access with caution. No access to internal porch.

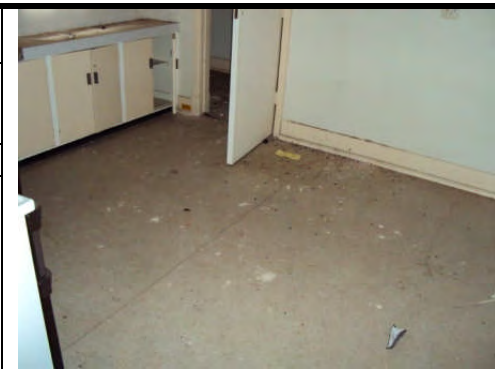
LOCATION - DESCRIPTION	EXTENT	ASBESTOS ASSESSMENT	CONDITION	SAMPLE NO VISUAL TEST	SIGNAGE STATUS
CZECHOWICZ HOUSE, Section 5.2 – 5.2.2. Internal, Corridor – south side of kitchen vinyl floor covering with backing material.	Approx 6m ² Accessible	Asbestos detected	Not assessed	Similar to original sample no. 2	Visible
SURVEY FINDINGS and HAZARD MANAGEMENT RECOMMENDATIONS					
<p>Low Risk P4 – Recommend planned removal in accordance with “Approved Code of Practice”. Backing layer trapped under vinyl. Item regarded safe whilst vinyl remains in good condition to protect from and prevent disturbance of asbestos backing layer.</p> <p>Avoid physical and mechanical damage. When maintenance/upgrade is required, recommend removal and reinstate with non-asbestos product.</p> <p>Note - as required by the OHS&W regulations, removal of this type of material is required to be performed by a licensed removalist.</p> <p>2010 Notes - No access to this item 2010 no key Building is derelict. Exercise caution when accessing as ceiling may collapse.</p> <p>June 2013/15/ Aug 2016/Sept 2017 - No access no keys available.</p>

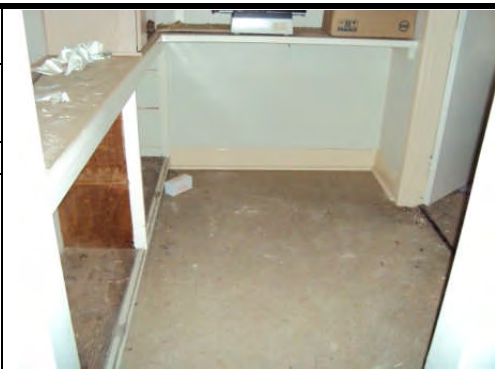
LOCATION - DESCRIPTION	EXTENT	ASBESTOS ASSESSMENT	CONDITION	SAMPLE NO VISUAL TEST	SIGNAGE STATUS
CZECHOWICZ HOUSE, Section 5.2 – 5.2.3. Internal, Store room – south side of kitchen – vinyl floor covering.	Approx 4m ² Accessible	Asbestos detected	Not assessed	Similar to original sample no. 2	Visible
SURVEY FINDINGS and HAZARD MANAGEMENT RECOMMENDATIONS					
<p>Low Risk P4 – Recommend planned removal in accordance with “Approved Code of Practice”. Backing layer trapped under vinyl. Item regarded safe whilst vinyl remains in good condition to protect from and prevent disturbance of asbestos backing layer.</p> <p>Avoid physical and mechanical damage. When maintenance/upgrade is required, recommend removal and reinstate with non-asbestos product.</p> <p>Note - as required by the OHS&W regulations, removal of this type of material is required to be performed by a licensed removalist.</p> <p>2010 Notes - No access to this item 2010 no key Building is derelict. Exercise caution when accessing as ceiling may collapse.</p> <p>June 2013/15/ Aug 2016/Sept 2017 - No access no keys available.</p>

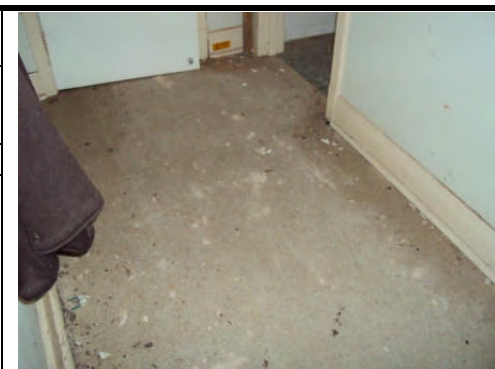
LOCATION - DESCRIPTION	EXTENT	ASBESTOS ASSESSMENT	CONDITION	SAMPLE NO VISUAL TEST	SIGNAGE STATUS
CZECHOWICZ HOUSE, Section 5.2 – 5.2.4. Internal, Lock-up files room – vinyl floor covering with backing material.	Approx 2m ² Accessible	Asbestos detected	Not assessed	Similar to original sample no. 2	Visible
SURVEY FINDINGS and HAZARD MANAGEMENT RECOMMENDATIONS					
<p>Low Risk P4 – Recommend planned removal in accordance with “Approved Code of Practice”. Backing layer trapped under vinyl. Item regarded safe whilst vinyl remains in good condition to protect from and prevent disturbance of asbestos backing layer.</p> <p>Avoid physical and mechanical damage. When maintenance/upgrade is required, recommend removal and reinstate with non-asbestos product.</p> <p>Note - as required by the OHS&W regulations, removal of this type of material is required to be performed by a licensed removalist.</p> <p>2010 Notes - No access to this item 2010 no key Building is derelict. Exercise caution when accessing as ceiling may collapse.</p> <p>June 2013/15/ Aug 2016/Sept 2017 - No access no keys available.</p>

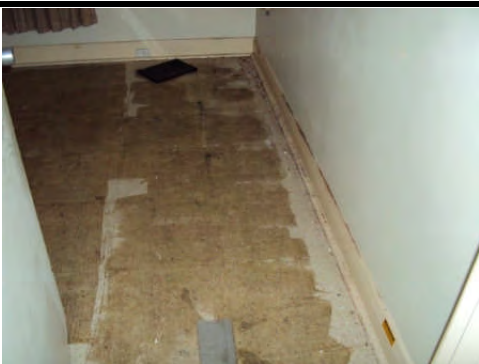
CZECHOWICZ HOUSE, Section 5.2 – 5.2.5. Internal, Southern entrance – vinyl floor covering with backing material.	Approx 2m ² Accessible	Asbestos detected	Not assessed	Similar to original sample no. 2	Visible	
SURVEY FINDINGS and HAZARD MANAGEMENT RECOMMENDATIONS Low Risk P4 – Recommend planned removal in accordance with “Approved Code of Practice”. Backing layer trapped under vinyl. Item regarded safe whilst vinyl remains in good condition to protect from and prevent disturbance of asbestos backing layer. Avoid physical and mechanical damage. When maintenance/upgrade is required, recommend removal and reinstate with non-asbestos product. Note - as required by the OHS&W regulations, removal of this type of material is required to be performed by a licensed removalist. 2010 Notes - No access to this item 2010 no key Building is derelict. Exercise caution when accessing as ceiling may collapse. June 2013/15/ Aug 2016/Sept 2017 - No access no keys available.

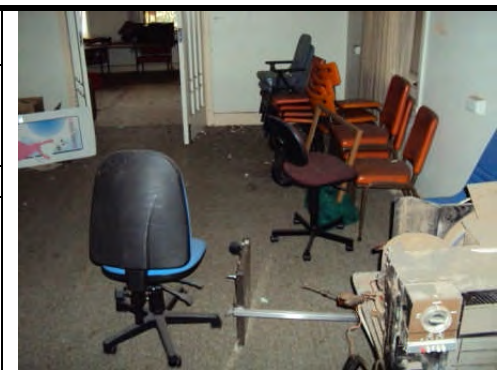
LOCATION - DESCRIPTION	EXTENT	ASBESTOS ASSESSMENT	CONDITION	SAMPLE NO VISUAL TEST	SIGNAGE STATUS
CZECHOWICZ HOUSE, Section 5.2 – 5.2.8. Internal, Corridor – vinyl floor covering with backing material. (covered by carpet)	Approx 20m ² Accessible	Asbestos detected	Not assessed	Similar to original sample no. 2	Visible
SURVEY FINDINGS and HAZARD MANAGEMENT RECOMMENDATIONS					
<p>Low Risk P4 – Recommend planned removal in accordance with “Approved Code of Practice”. Backing layer trapped under vinyl. Item regarded safe whilst vinyl remains in good condition to protect from and prevent disturbance of asbestos backing layer.</p> <p>Avoid physical and mechanical damage. When maintenance/upgrade is required, recommend removal and reinstate with non-asbestos product.</p> <p>Note - as required by the OHS&W regulations, removal of this type of material is required to be performed by a licensed removalist.</p> <p>2010 Notes - No access to this item 2010 no key Building is derelict. Exercise caution when accessing as ceiling may collapse.</p> <p>June 2013/15/ Aug 2016/Sept 2017 - No access no keys available.</p>

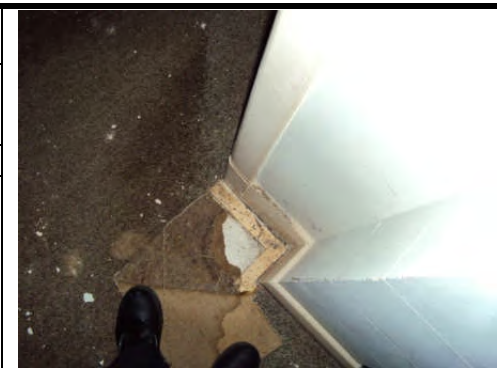
LOCATION - DESCRIPTION	EXTENT	ASBESTOS ASSESSMENT	CONDITION	SAMPLE NO VISUAL TEST	SIGNAGE STATUS
CZECHOWICZ HOUSE, Section 5.2 – 5.2.9. Internal, North west office – vinyl floor covering with backing material. (covered by carpet)	Approx 15m ² Accessible	Asbestos detected	Not assessed	Similar to original sample no. 2	Visible
SURVEY FINDINGS and HAZARD MANAGEMENT RECOMMENDATIONS					
<p>Low Risk P4 – Recommend planned removal in accordance with “Approved Code of Practice”. Backing layer trapped under vinyl. Item regarded safe whilst vinyl remains in good condition to protect from and prevent disturbance of asbestos backing layer.</p> <p>Avoid physical and mechanical damage. When maintenance/upgrade is required, recommend removal and reinstate with non-asbestos product.</p> <p>Note - as required by the OHS&W regulations, removal of this type of material is required to be performed by a licensed removalist.</p> <p>2010 Notes - No access to this item 2010 no key Building is derelict. Exercise caution when accessing as ceiling may collapse.</p> <p>June 2013/15/ Aug 2016/Sept 2017 - No access no keys available.</p>

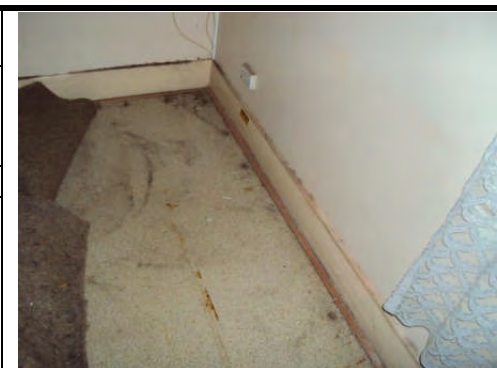
LOCATION - DESCRIPTION	EXTENT	ASBESTOS ASSESSMENT	CONDITION	SAMPLE NO VISUAL TEST	SIGNAGE STATUS	
CZECHOWICZ HOUSE, Section 5.2 – 5.2.10. Internal, South east office – vinyl floor covering with backing material. (covered by carpet)	Approx 12m ² Accessible	Asbestos detected	Not assessed	Similar to original sample no. 2	Visible

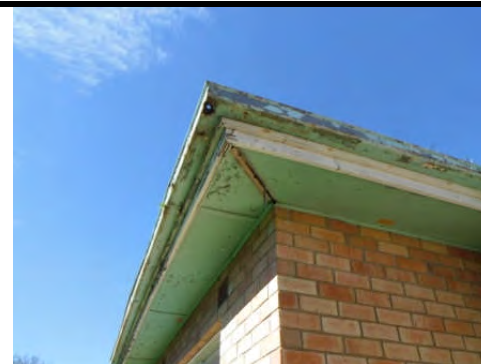
LOCATION - DESCRIPTION	EXTENT	ASBESTOS ASSESSMENT	CONDITION	SAMPLE NO VISUAL TEST	SIGNAGE STATUS
HEASLIP HOUSE, Section 5.3 – 5.3.2. External, Front porch lining – fibre cement sheet.	Approx 5m ² Limited access	Asbestos detected	Moderate Unsealed Non friable	Similar to original sample no. 3	Visible
SURVEY FINDINGS and HAZARD MANAGEMENT RECOMMENDATIONS					
<p>Low Risk P4 – Avoid physical and mechanical damage. When maintenance/upgrade is required, recommend removal and reinstate with non-asbestos product.</p> <p>August 2016 – Paint in poor condition. Access with caution.</p> <p>September 2017 – Paint in poor condition. Monitor for further signs of deterioration. Access with caution.</p>

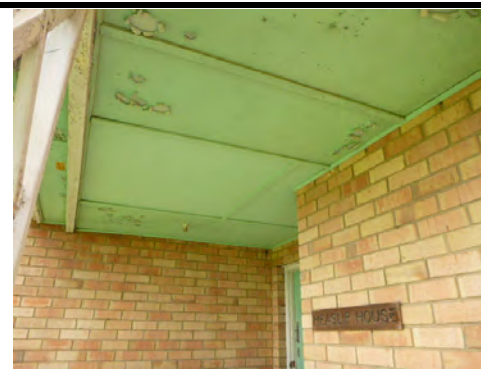
LOCATION - DESCRIPTION	EXTENT	ASBESTOS ASSESSMENT	CONDITION	SAMPLE NO VISUAL TEST	SIGNAGE STATUS
HEASLIP HOUSE, Section 5.3 – 5.3.3. External, Front porch, southern gable lining – fibre cement sheet.	Approx 1m ² Limited access	Asbestos detected	Moderate Unsealed Non friable	Similar to original sample no. 3	Visible
<i>SURVEY FINDINGS and HAZARD MANAGEMENT RECOMMENDATIONS</i>					
Low Risk P4 – Avoid physical and mechanical damage. When maintenance/upgrade is required, recommend removal and reinstate with non-asbestos product.					
September 2017 – Paint in poor condition. Monitor for further signs of deterioration. Access with caution.

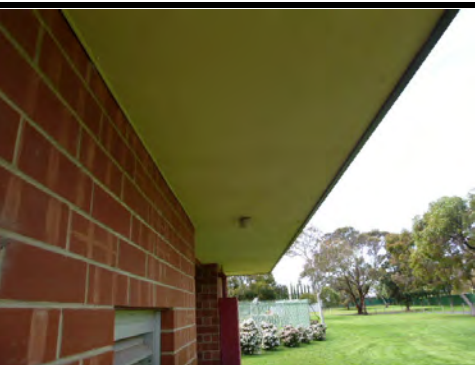
LOCATION - DESCRIPTION	EXTENT	ASBESTOS ASSESSMENT	CONDITION	SAMPLE NO VISUAL TEST	SIGNAGE STATUS
MAKK HOUSE, Section 5.5 – 5.5.2. External, Eastern entrance porch lining – fibre cement sheet.	Approx. 5m ² Limited access	Asbestos detected	Good Sealed Non friable	Similar to original sample no. 6	Visible
SURVEY FINDINGS and HAZARD MANAGEMENT RECOMMENDATIONS					
Low Risk P4 – Avoid physical and mechanical damage. When maintenance/upgrade is required, recommend removal and reinstate with non-asbestos product.

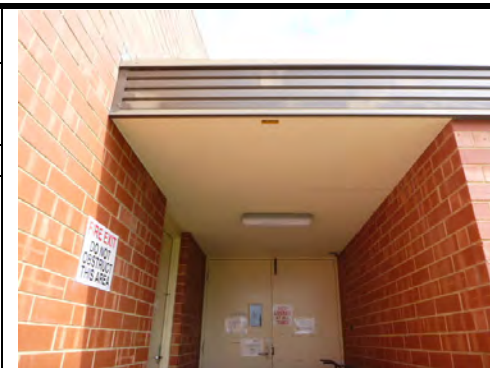
LOCATION - DESCRIPTION	EXTENT	ASBESTOS ASSESSMENT	CONDITION	SAMPLE NO VISUAL TEST	SIGNAGE STATUS
MAKK HOUSE, Section 5.5 – 5.5.3. External, Kitchen entrance porch, eastern side lining – fibre cement sheet.	Approx 8m ² Limited access	Asbestos detected	Good Sealed Non friable	Similar to original sample no. 6	Visible
SURVEY FINDINGS and HAZARD MANAGEMENT RECOMMENDATIONS					
Low Risk P4 – Avoid physical and mechanical damage. When maintenance/upgrade is required, recommend removal and reinstate with non-asbestos product.

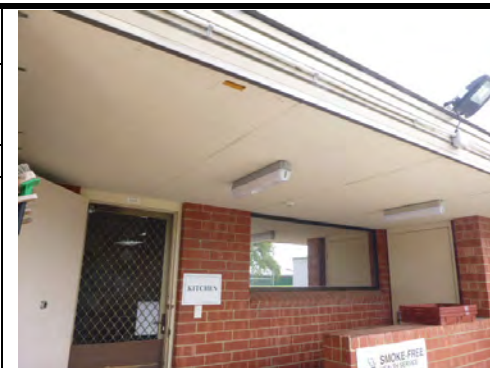
LOCATION - DESCRIPTION	EXTENT	ASBESTOS ASSESSMENT	CONDITION	SAMPLE NO VISUAL TEST	SIGNAGE STATUS
MAKK HOUSE, Section 5.5 – 5.5.4. External, Eastern courtyard eaves lining – fibre cement sheet.	Approx 100m ² Limited access	Asbestos detected	Good Sealed Non friable	Similar to original sample no. 6	Visible
SURVEY FINDINGS and HAZARD MANAGEMENT RECOMMENDATIONS					
Low Risk P4 – Avoid physical and mechanical damage. When maintenance/upgrade is required, recommend removal and reinstate with non-asbestos product.

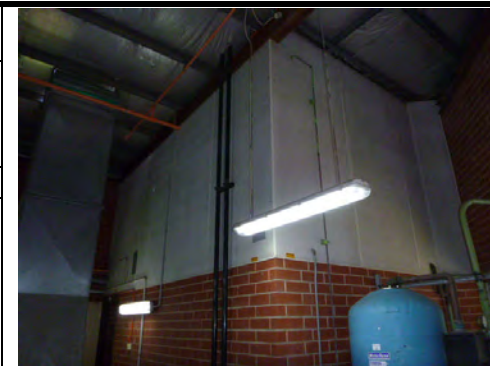
LOCATION - DESCRIPTION	EXTENT	ASBESTOS ASSESSMENT	CONDITION	SAMPLE NO VISUAL TEST	SIGNAGE STATUS
MAKK HOUSE, Section 5.5 – 5.5.6. Internal, HWS plant room (Rm G31), upper section of wall lining – fibre cement sheet.	Approx 25m ² Limited access	Asbestos detected	Moderate Unsealed Non friable	Similar to original sample no. 6	Visible
SURVEY FINDINGS and HAZARD MANAGEMENT RECOMMENDATIONS					
Low Risk P4 – Avoid physical and mechanical damage. When maintenance/upgrade is required, recommend removal and reinstate with non-asbestos product.

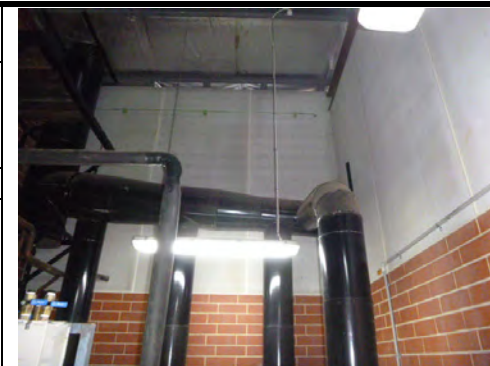
LOCATION - DESCRIPTION	EXTENT	ASBESTOS ASSESSMENT	CONDITION	SAMPLE NO VISUAL TEST	SIGNAGE STATUS
BASEMENT (UNDERGROUND VOID), Section 5.6 – 5.6.1. Retaining wall lining – fibre cement sheet.	Approx 50m ² Limited access	Asbestos detected	Not assessed	Original sample no. 7	Visible
SURVEY FINDINGS and HAZARD MANAGEMENT RECOMMENDATIONS					
Low Risk P4 – Avoid physical and mechanical damage. When maintenance/upgrade is required, recommend removal and reinstate with non-asbestos product.					
August 2016/Sept 2017 - No access / confined space area. Access with caution.

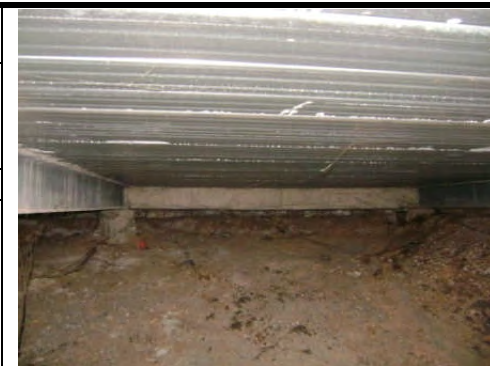
LOCATION - DESCRIPTION	EXTENT	ASBESTOS ASSESSMENT	CONDITION	SAMPLE NO VISUAL TEST	SIGNAGE STATUS
BASEMENT (UNDERGROUND VOID), Section 5.6 – 5.6.2. Basement vent pipes – formed cement pipes. (Access via room G30)	8 Pipes, Approx 400mm dia. x 4m Accessible	Asbestos detected	Not assessed	Original sample no. 8	Visible
SURVEY FINDINGS and HAZARD MANAGEMENT RECOMMENDATIONS					
Low Risk P4 – Avoid physical and mechanical damage. When maintenance/upgrade is required, recommend removal and reinstate with non-asbestos product.					
2010 Notes - These pipes continue into the earth before surfacing as vents at ground level.					
August 2016/Sept 2017 - No access / confined space area. Access with caution.

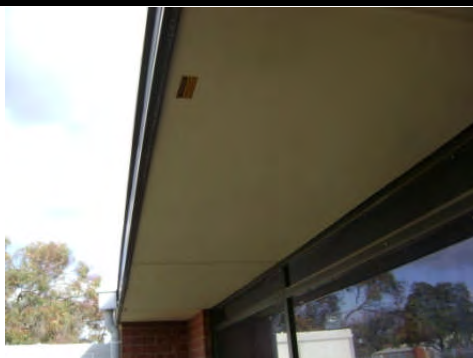
LOCATION - DESCRIPTION	EXTENT	ASBESTOS ASSESSMENT	CONDITION	SAMPLE NO VISUAL TEST	SIGNAGE STATUS
McLEAY HOUSE, Section 5.8 – 5.8.2. External, Eastern entrance porch lining – fibre cement sheet.	Approx 4m ² Limited access	Asbestos detected	Good Sealed Non friable	Similar to original sample no. 6	Visible
<i>SURVEY FINDINGS and HAZARD MANAGEMENT RECOMMENDATIONS</i>					
Low Risk P4 – Avoid physical and mechanical damage. When maintenance/upgrade is required, recommend removal and reinstate with non-asbestos product.

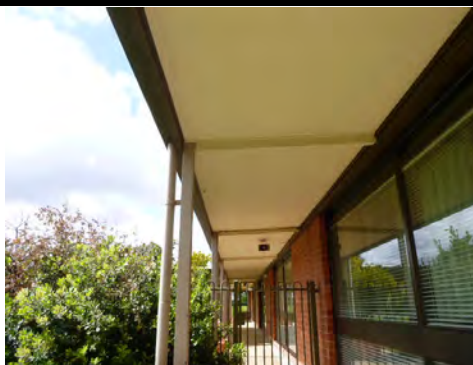
LOCATION - DESCRIPTION	EXTENT	ASBESTOS ASSESSMENT	CONDITION	SAMPLE NO VISUAL TEST	SIGNAGE STATUS
McLEAY HOUSE, Section 5.8 – 5.8.4. External, Northern plant room eaves lining – fibre cement sheet.	Approx 26m ² Limited access	Asbestos detected	Good Sealed Non friable	Similar to original sample no. 6	Visible
SURVEY FINDINGS and HAZARD MANAGEMENT RECOMMENDATIONS					
Low Risk P4 – Avoid physical and mechanical damage. When maintenance/upgrade is required, recommend removal and reinstate with non-asbestos product.

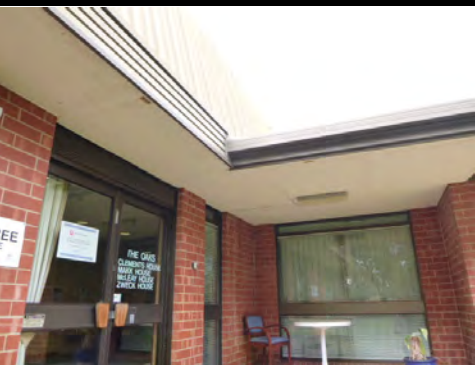
LOCATION - DESCRIPTION	EXTENT	ASBESTOS ASSESSMENT	CONDITION	SAMPLE NO VISUAL TEST	SIGNAGE STATUS
ZWECK HOUSE (formally Clements House), Section 5.11 – 5.11.2. External, Northern verandah lining – fibre cement sheet.	Approx 30m ² Limited access	Asbestos detected	Good Sealed Non friable	Similar to original sample no. 6	Visible
<i>SURVEY FINDINGS and HAZARD MANAGEMENT RECOMMENDATIONS</i>					
Low Risk P4 – Avoid physical and mechanical damage. When maintenance/upgrade is required, recommend removal and reinstate with non-asbestos product.

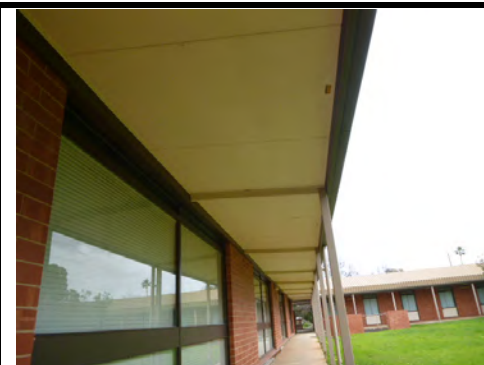
LOCATION - DESCRIPTION	EXTENT	ASBESTOS ASSESSMENT	CONDITION	SAMPLE NO VISUAL TEST	SIGNAGE STATUS	
ZWECK HOUSE (formally Clements House), Section 5.11 – 5.11.3. External, Western entrance porch lining – fibre cement sheet.	Approx 4m ² Limited access	Asbestos detected	Good Sealed Non friable	Similar to original sample no. 6	Visible

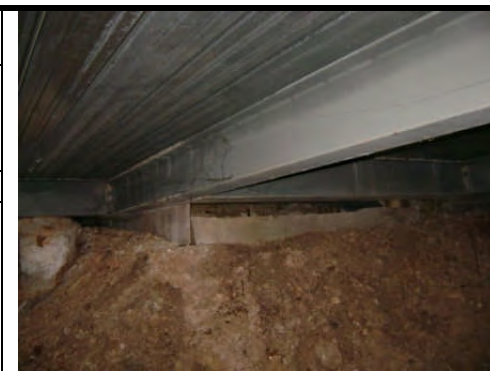
LOCATION - DESCRIPTION	EXTENT	ASBESTOS ASSESSMENT	CONDITION	SAMPLE NO VISUAL TEST	SIGNAGE STATUS
BASEMENT (UNDERGROUND VOID), Section 5.12 – 5.12.2. Air conditioner flange joints - mastic.	Every flange joint	Presume asbestos content	Not assessed	Original sample no. 9	Visible
SURVEY FINDINGS and HAZARD MANAGEMENT RECOMMENDATIONS					
Low Risk P4 – Recommend sample (x4) to qualify material content, otherwise treat item as asbestos containing. Avoid physical and mechanical damage. When maintenance/upgrade is required, recommend removal and reinstate with non-asbestos product. August 2016/Sept 2017 - No access / confined space area. Access with caution.

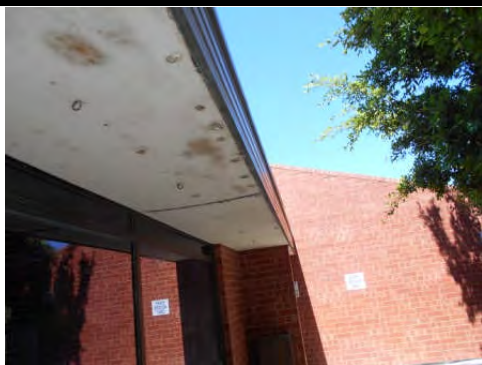
LOCATION - DESCRIPTION	EXTENT	ASBESTOS ASSESSMENT	CONDITION	SAMPLE NO VISUAL TEST	SIGNAGE STATUS
CLEMENTS HOUSE (formally Zweck House), Section 5.14 – 5.14.2. External, Western entrance porch lining – fibre cement sheet.	Approx 4m ² Limited access	Asbestos detected	Good Sealed Non friable	Similar to original sample no. 6	Visible
<i>SURVEY FINDINGS and HAZARD MANAGEMENT RECOMMENDATIONS</i>					
Low Risk P4 – Avoid physical and mechanical damage. When maintenance/upgrade is required, recommend removal and reinstate with non-asbestos product.

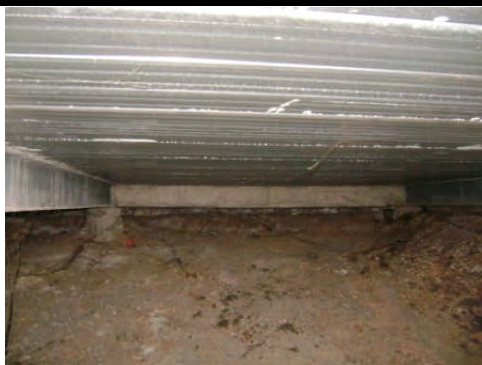
BASEMENT (UNDERGROUND VOID), Section 5.15 – 5.15.1. Retaining walls –cement sheet.	Approx 50m ² Accessible	Asbestos detected	Not assessed	Similar to original sample no. 7	Visible	
<i>SURVEY FINDINGS and HAZARD MANAGEMENT RECOMMENDATIONS</i>						
Low Risk P4 – Avoid physical and mechanical damage. When maintenance/upgrade is required, recommend removal and reinstate with non-asbestos product. August 2016/Sept 2017 - No access / confined space area. Access with caution.

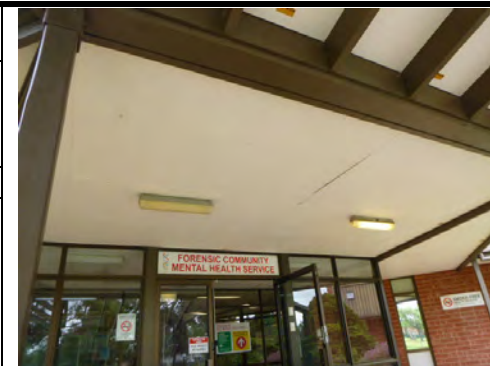
LOCATION - DESCRIPTION	EXTENT	ASBESTOS ASSESSMENT	CONDITION	SAMPLE NO VISUAL TEST	SIGNAGE STATUS
HOWARD HOUSE, Section 5.17 – 5.17.2. External, Window infills to perimeter of building (including adjacent to doors) – fibre cement sheet.	Approx 100m ² Accessible	Asbestos detected	Good Sealed Non friable	Original sample no. 13	Visible
SURVEY FINDINGS and HAZARD MANAGEMENT RECOMMENDATIONS					
Low Risk P4 – Avoid physical and mechanical damage. When maintenance/upgrade is required, recommend removal and reinstate with non-asbestos product.

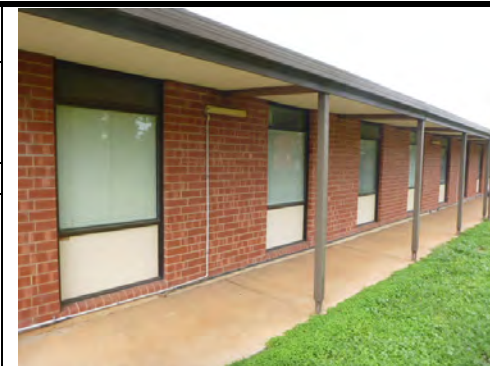
LOCATION - DESCRIPTION	EXTENT	ASBESTOS ASSESSMENT	CONDITION	SAMPLE NO VISUAL TEST	SIGNAGE STATUS
HOWARD HOUSE, Section 5.17 – 5.17.3. External, North Eastern verandah lining – fibre cement sheet.	Approx 30m ² Limited access	Asbestos detected	Good Sealed Non friable	Similar to original sample no. 12	Visible
SURVEY FINDINGS and HAZARD MANAGEMENT RECOMMENDATIONS					
Low Risk P4 – Avoid physical and mechanical damage. When maintenance/upgrade is required, recommend removal and reinstate with non-asbestos product.

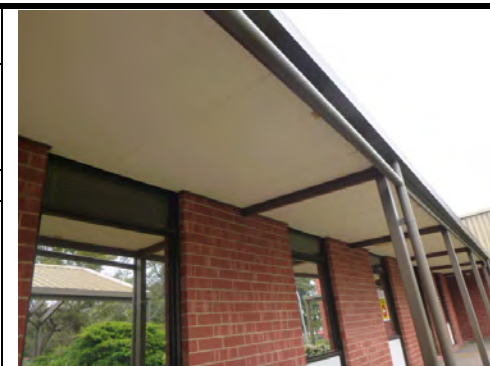
LOCATION - DESCRIPTION	EXTENT	ASBESTOS ASSESSMENT	CONDITION	SAMPLE NO VISUAL TEST	SIGNAGE STATUS
HOWARD HOUSE, Section 5.17 – 5.17.4. External, Eastern verandah / Entrance foyer lining – fibre cement sheet.	Approx 150m ² Limited access	Asbestos detected	Good Sealed Non friable	Similar to original sample no. 12	Visible
SURVEY FINDINGS and HAZARD MANAGEMENT RECOMMENDATIONS					
Low Risk P4 – Avoid physical and mechanical damage. When maintenance/upgrade is required, recommend removal and reinstate with non-asbestos product. August 2016 – Damaged timber beam to north eastern main entry.

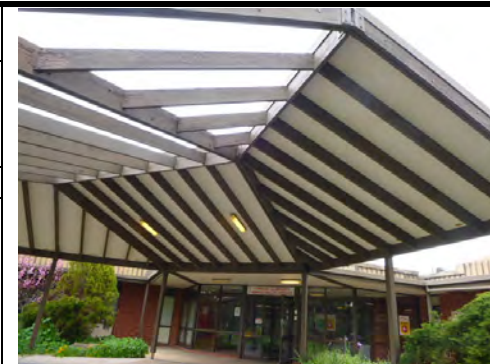
LOCATION - DESCRIPTION	EXTENT	ASBESTOS ASSESSMENT	CONDITION	SAMPLE NO VISUAL TEST	SIGNAGE STATUS
HOWARD HOUSE, Section 5.17 – 5.17.5. External / Internal, Southern entrance verandah lining – fibre cement sheet.	Approx 8m ² Accessible	Asbestos detected	Good Sealed Non friable	Similar to original sample no. 12	Visible
SURVEY FINDINGS and HAZARD MANAGEMENT RECOMMENDATIONS					
Low Risk P4 – Avoid physical and mechanical damage. When maintenance/upgrade is required, recommend removal and reinstate with non-asbestos product.

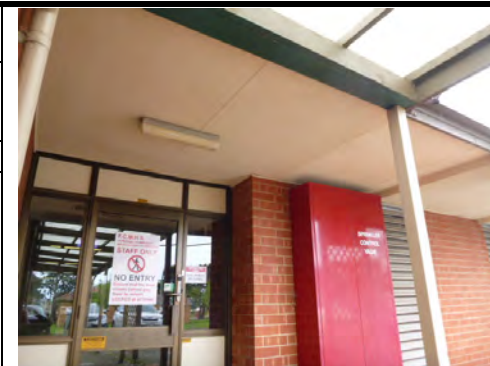
LOCATION - DESCRIPTION	EXTENT	ASBESTOS ASSESSMENT	CONDITION	SAMPLE NO VISUAL TEST	SIGNAGE STATUS
HOWARD HOUSE, Section 5.17 – 5.17.6. External, Eastern verandah lining – fibre cement sheet.	Approx 30m ² Limited access	Asbestos detected	Good Sealed Non friable	Similar to original sample no. 12	Visible
SURVEY FINDINGS and HAZARD MANAGEMENT RECOMMENDATIONS					
Low Risk P4 – Avoid physical and mechanical damage. When maintenance/upgrade is required, recommend removal and reinstate with non-asbestos product.

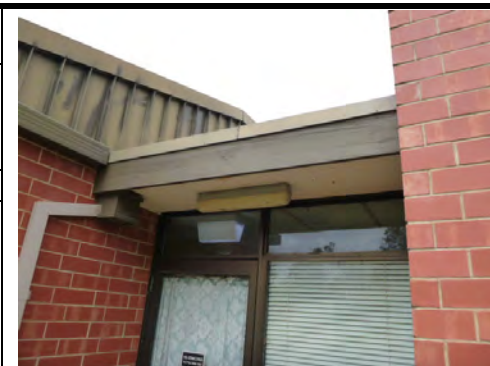
LOCATION - DESCRIPTION	EXTENT	ASBESTOS ASSESSMENT	CONDITION	SAMPLE NO VISUAL TEST	SIGNAGE STATUS
HOWARD HOUSE, Section 5.17 – 5.17.7. External, Solarium, covered walkways, walls, and lower infills – fibre cement sheet.	Approx 22m ² Accessible	Asbestos detected	Good Sealed Non friable	Similar to original sample no. 12	Visible
SURVEY FINDINGS and HAZARD MANAGEMENT RECOMMENDATIONS					
Low Risk P4 – Avoid physical and mechanical damage. When maintenance/upgrade is required, recommend removal and reinstate with non-asbestos product.

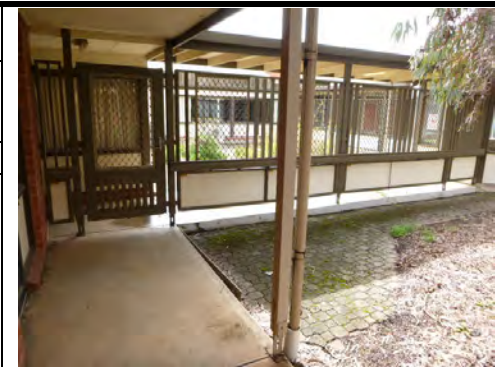
LOCATION - DESCRIPTION	EXTENT	ASBESTOS ASSESSMENT	CONDITION	SAMPLE NO VISUAL TEST	SIGNAGE STATUS
HOWARD HOUSE, Section 5.17 – 5.17.8. External, Solarium, courtyard walls lining – fibre cement sheet.	Approx 10m ² Accessible	Asbestos detected	Good Sealed Non friable	Similar to original sample no. 12	Visible
SURVEY FINDINGS and HAZARD MANAGEMENT RECOMMENDATIONS					
Low Risk P4 – Avoid physical and mechanical damage. When maintenance/upgrade is required, recommend removal and reinstate with non-asbestos product.

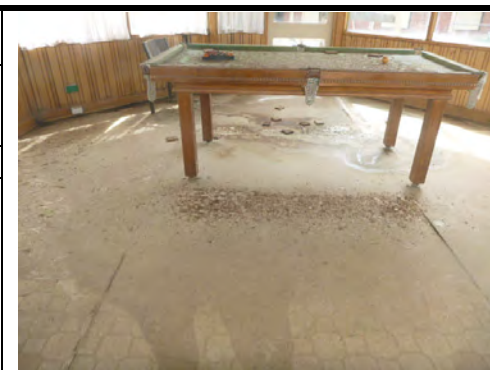
LOCATION - DESCRIPTION	EXTENT	ASBESTOS ASSESSMENT	CONDITION	SAMPLE NO VISUAL TEST	SIGNAGE STATUS
HOWARD HOUSE, Section 5.17 – 5.17.11. External, Solarium, upper infills – fibre cement sheet.	Approx 6m ² Limited access	Asbestos detected	Good Sealed Non friable	Similar to original sample no. 12	Visible
SURVEY FINDINGS and HAZARD MANAGEMENT RECOMMENDATIONS					
<p>Low Risk P4 – Avoid physical and mechanical damage. When maintenance/upgrade is required, recommend removal and reinstate with non-asbestos product.</p>
