# Preliminary Site Investigation

Gilles Plains TAFE

Client: Renewal SA

27-Jul-2019

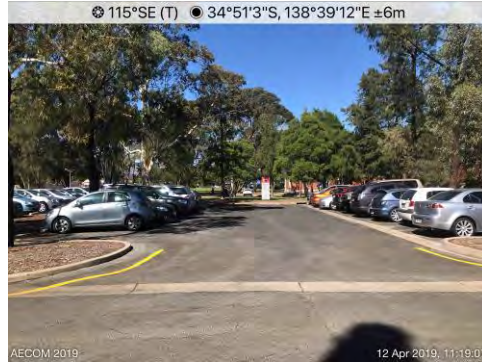
<b>Site Name:</b> Gilles Plains TAFE		<b>Site Location:</b> Blacks Road, Gilles Plains	
<b>Plate No.</b> 3.			
<b>Description:</b> Site northern car park.

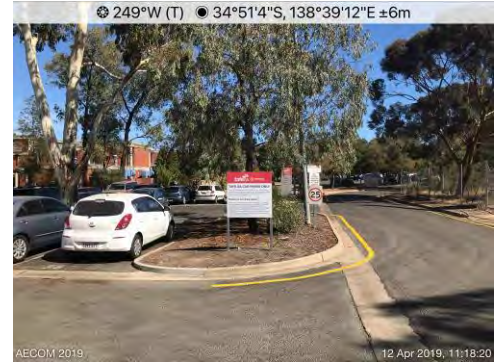
<b>Site Name:</b> Gilles Plains TAFE		<b>Site Location:</b> Blacks Road, Gilles Plains	
<b>Plate No.</b> 4.			
<b>Description:</b> Site northern car park.
