Preliminary Site Investigation

Former Oakden Older Persons Mental Health Facility

Client: Renewal SA

08-May-2019

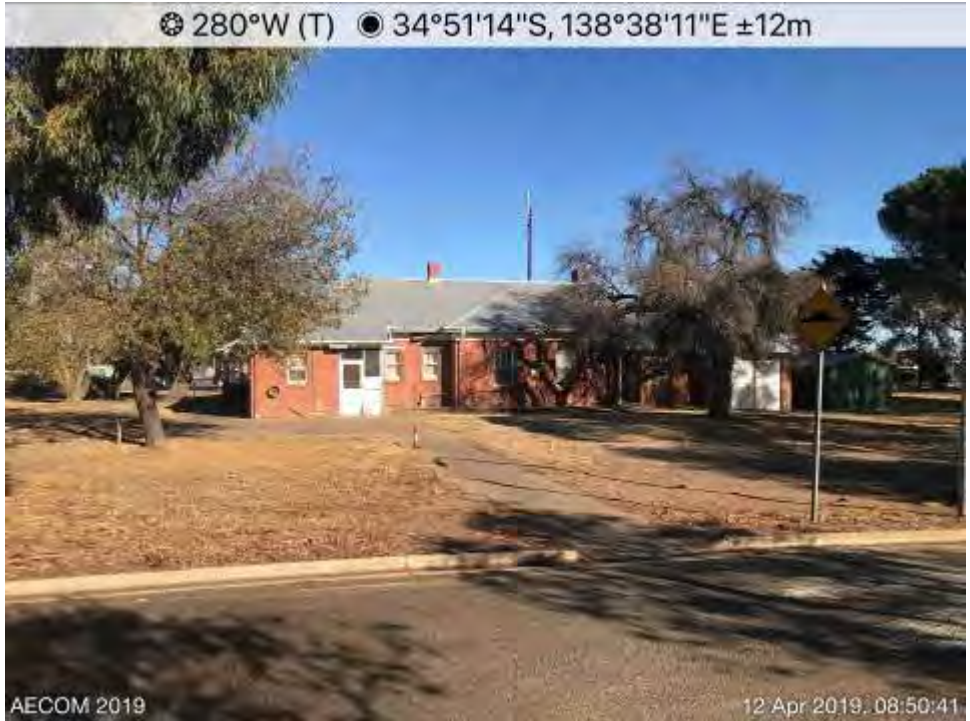
Site Name: Former Oakden Older Person Mental Health Facility		Site Location: 200-202 Fosters Road Oakden	
Plate No. 13.

<p>⊗ 280°W (T) ● 34°51'14"S, 138°38'11"E ±12m</p> <p>AECOM 2019 12 Apr 2019, 08:50:41</p>		
Description: Eastern side of Czechowicz House

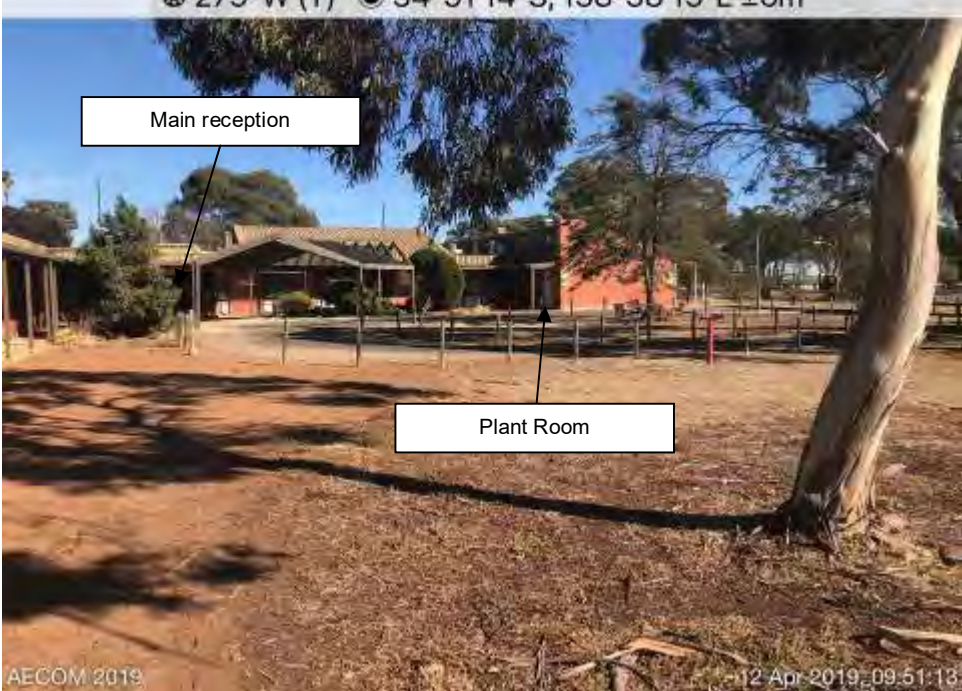
Site Name: Former Oakden Older Person Mental Health Facility	Site Location: 200-202 Fosters Road Oakden
Plate No. 16.

Description: Eastern side of Howards Building.

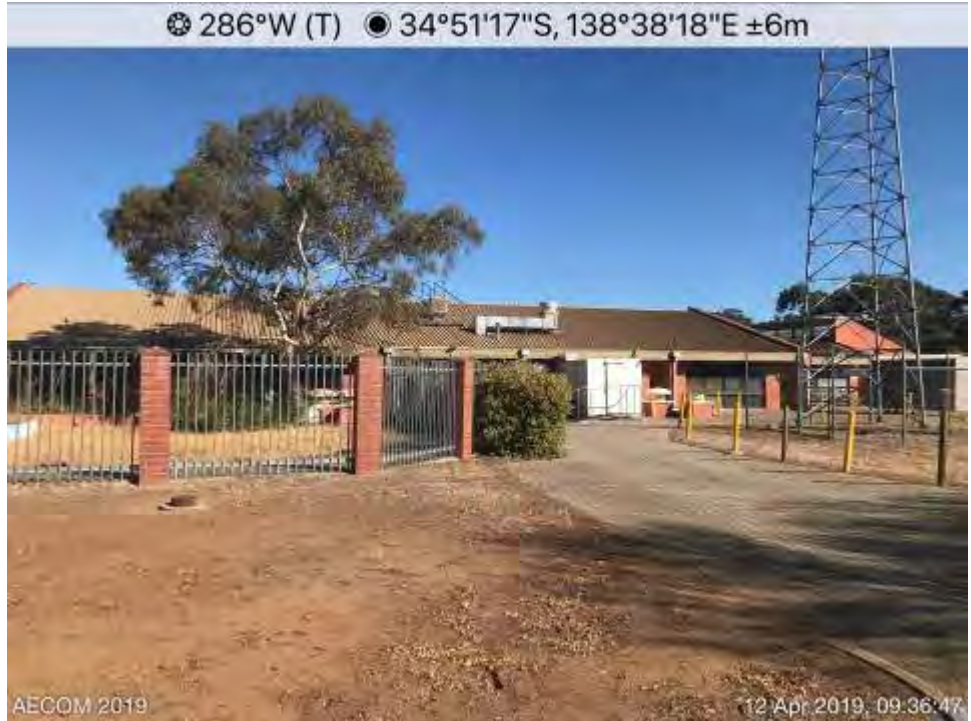
Site Name: Former Oakden Older Person Mental Health Facility		Site Location: 200-202 Fosters Road, Oakden	
Plate No. 25.

<p>☼ 286°W (T) ● 34°51'17"S, 138°38'18"E ±6m</p>		
Description: The Oaks building. Eastern side of Oaks building.

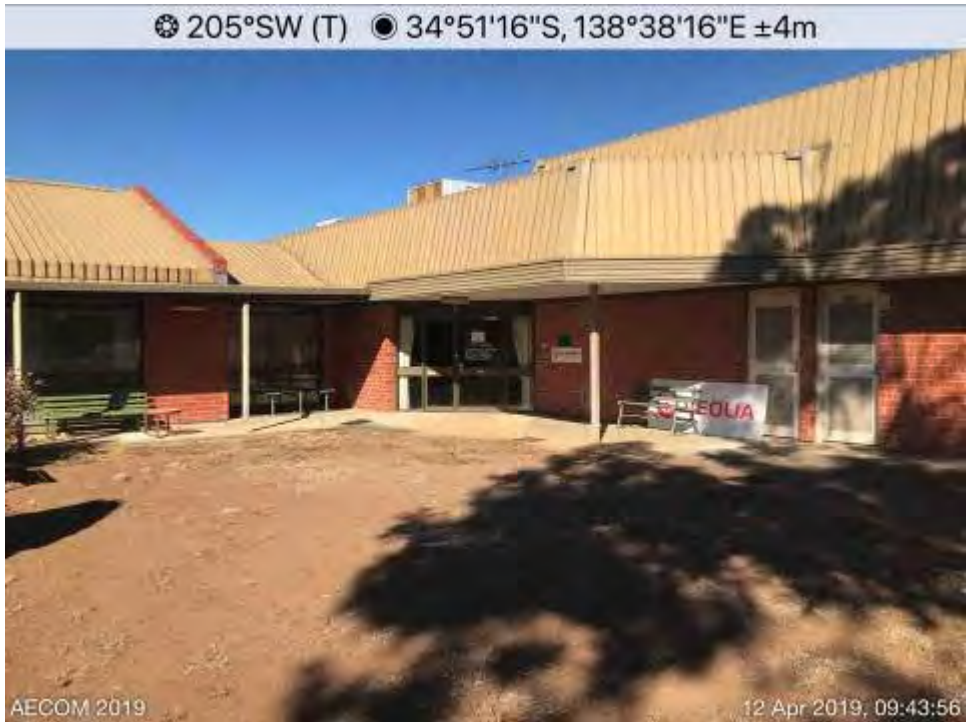
Site Name: Former Oakden Older Person Mental Health Facility		Site Location: 200-202 Fosters Road Oakden	
Plate No. 27.	<div><div>☼ 205°SW (T) ● 34°51'16"S, 138°38'16"E ±4m</div>

<div>AECOM 201912 Apr 2019, 09:43:56</div></div>		
Description: The Oaks building. Northern side of Oaks building.

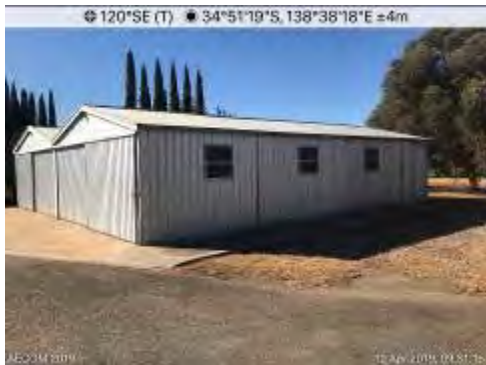
Site Name: Former Oakden Older Person Mental Health Facility		Site Location: 200-202 Fosters Road Oakden	
Plate No. 30.

Description: Shed C Interior of Shed C showing miscellaneous office equipment, nursing equipment and two gas bottles.

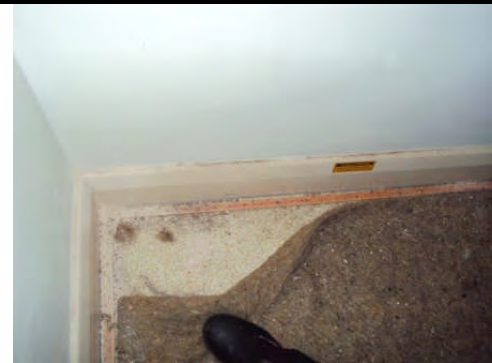
LOCATION - DESCRIPTION	EXTENT	ASBESTOS ASSESSMENT	CONDITION	SAMPLE NO VISUAL TEST	SIGNAGE STATUS	
CZECHOWICZ HOUSE, Section 5.2 – 5.2.10. Internal, South east office – vinyl floor covering with backing material. (covered by carpet)	Approx 12m ² Accessible	Asbestos detected	Not assessed	Similar to original sample no. 2	Visible

SURVEY FINDINGS and HAZARD MANAGEMENT RECOMMENDATIONS						
<p>Low Risk P4 – Recommend planned removal in accordance with “Approved Code of Practice”. Backing layer trapped under vinyl. Item regarded safe whilst vinyl remains in good condition to protect from and prevent disturbance of asbestos backing layer.</p> <p>Avoid physical and mechanical damage. When maintenance/upgrade is required, recommend removal and reinstate with non-asbestos product.</p> <p>Note - as required by the OHS&W regulations, removal of this type of material is required to be performed by a licensed removalist.</p> <p>2010 Notes - No access to this item 2010 no key Building is derelict. Exercise caution when accessing as ceiling may collapse.</p> <p>June 2013/15/ Aug 2016/Sept 2017 - No access no keys available.</p>

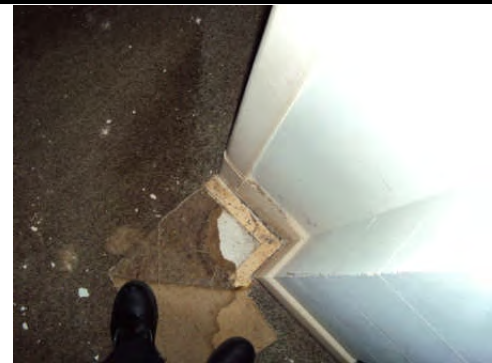
LOCATION - DESCRIPTION	EXTENT	ASBESTOS ASSESSMENT	CONDITION	SAMPLE NO VISUAL TEST	SIGNAGE STATUS	
CZECHOWICZ HOUSE, Section 5.2 – 5.2.11. Internal, Lounge – vinyl floor covering with backing material. (covered by carpet)	Approx 25m ² Accessible	Asbestos detected	Not assessed	Similar to original sample no. 2	Visible

SURVEY FINDINGS and HAZARD MANAGEMENT RECOMMENDATIONS						
<p>Low Risk P4 – Recommend planned removal in accordance with “Approved Code of Practice”. Backing layer trapped under vinyl. Item regarded safe whilst vinyl remains in good condition to protect from and prevent disturbance of asbestos backing layer.</p> <p>Avoid physical and mechanical damage. When maintenance/upgrade is required, recommend removal and reinstate with non-asbestos product.</p> <p>Note - as required by the OHS&W regulations, removal of this type of material is required to be performed by a licensed removalist.</p> <p>2010 Notes - No access to this item 2010 no key Building is derelict. Exercise caution when accessing as ceiling may collapse.</p> <p>June 2013/15/ Aug 2016/Sept 2017 - No access no keys available.</p>

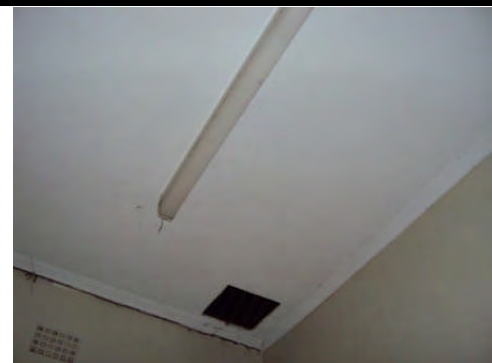
LOCATION - DESCRIPTION	EXTENT	ASBESTOS ASSESSMENT	CONDITION	SAMPLE NO VISUAL TEST	SIGNAGE STATUS	
CZECHOWICZ HOUSE, Section 5.2 – 5.2.12. Internal, Rear toilet ceiling lining - "Hardiflex" cement sheet.	Approx 2m ² Accessible	Presume asbestos content	Not assessed	Visual	Visible

SURVEY FINDINGS and HAZARD MANAGEMENT RECOMMENDATIONS						
<p>Low Risk P4 –Avoid physical and mechanical damage. When maintenance/upgrade is required, recommend removal and reinstate with non-asbestos product.</p> <p>Recommend sample (x1) to qualify material content, otherwise treat item as asbestos containing.</p> <p>June 2013/15/ Aug 2016/Sept 2017 - No access no keys available.</p>

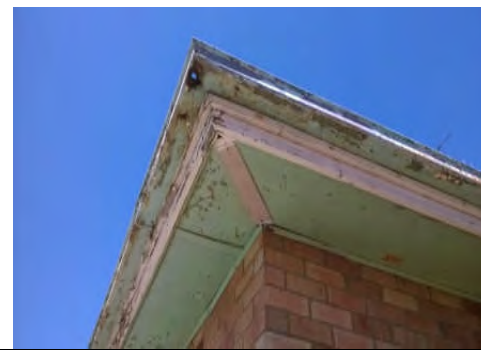
LOCATION - DESCRIPTION	EXTENT	ASBESTOS ASSESSMENT	CONDITION	SAMPLE NO VISUAL TEST	SIGNAGE STATUS
HEASLIP HOUSE, Section 5.3 – 5.3.2. External, Front porch lining – fibre cement sheet.	Approx 5m ² Limited access	Asbestos detected	Moderate Unsealed Non friable	Similar to original sample no. 3	Visible
SURVEY FINDINGS and HAZARD MANAGEMENT RECOMMENDATIONS					
<p>Low Risk P4 – Avoid physical and mechanical damage. When maintenance/upgrade is required, recommend removal and reinstate with non-asbestos product.</p> <p>August 2016 – Paint in poor condition. Access with caution.</p> <p>September 2017 – Paint in poor condition. Monitor for further signs of deterioration. Access with caution.</p>

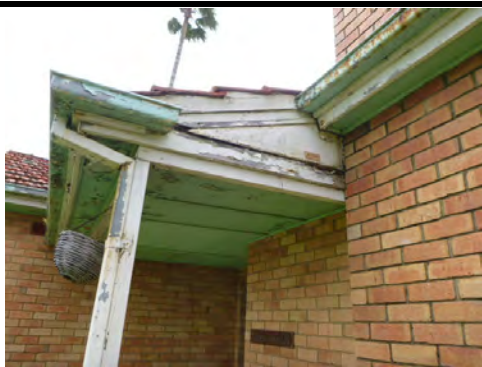
LOCATION - DESCRIPTION	EXTENT	ASBESTOS ASSESSMENT	CONDITION	SAMPLE NO VISUAL TEST	SIGNAGE STATUS
HEASLIP HOUSE, Section 5.3 – 5.3.3. External, Front porch, southern gable lining – fibre cement sheet.	Approx 1m ² Limited access	Asbestos detected	Moderate Unsealed Non friable	Similar to original sample no. 3	Visible
<i>SURVEY FINDINGS and HAZARD MANAGEMENT RECOMMENDATIONS</i>					
Low Risk P4 – Avoid physical and mechanical damage. When maintenance/upgrade is required, recommend removal and reinstate with non-asbestos product.					
September 2017 – Paint in poor condition. Monitor for further signs of deterioration. Access with caution.

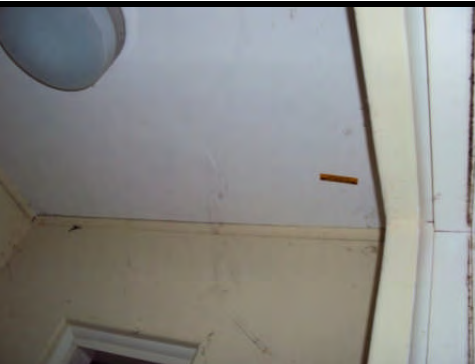
LOCATION - DESCRIPTION	EXTENT	ASBESTOS ASSESSMENT	CONDITION	SAMPLE NO VISUAL TEST	SIGNAGE STATUS
HEASLIP HOUSE, Section 5.4 – 5.4.3. Internal, Laundry ceiling lining – fibre cement sheet.	Approx 5m ² Limited access	Asbestos detected	Not assessed	Similar to original sample no. 4	Visible
<i>SURVEY FINDINGS and HAZARD MANAGEMENT RECOMMENDATIONS</i>					
Low Risk P4 – Avoid physical and mechanical damage. When maintenance/upgrade is required, recommend removal and reinstate with non-asbestos product. 2011 Notes – No access to this room / item due to no key. Treat as asbestos containing until qualified by inspection. Access with caution. June 2013/15/ Aug 2016/Sept 2017 - No access no keys available.

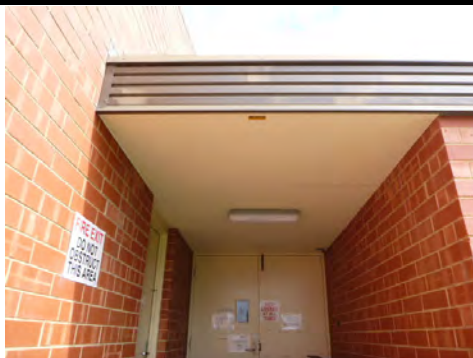
LOCATION - DESCRIPTION	EXTENT	ASBESTOS ASSESSMENT	CONDITION	SAMPLE NO VISUAL TEST	SIGNAGE STATUS
McLEAY HOUSE, Section 5.8 – 5.8.2. External, Eastern entrance porch lining – fibre cement sheet.	Approx 4m ² Limited access	Asbestos detected	Good Sealed Non friable	Similar to original sample no. 6	Visible
<i>SURVEY FINDINGS and HAZARD MANAGEMENT RECOMMENDATIONS</i>					
Low Risk P4 – Avoid physical and mechanical damage. When maintenance/upgrade is required, recommend removal and reinstate with non-asbestos product.

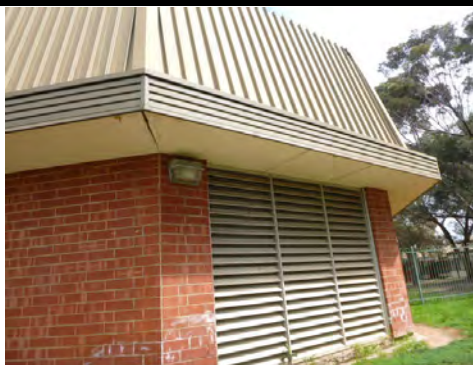
LOCATION - DESCRIPTION	EXTENT	ASBESTOS ASSESSMENT	CONDITION	SAMPLE NO VISUAL TEST	SIGNAGE STATUS
McLEAY HOUSE, Section 5.8 – 5.8.4. External, Northern plant room eaves lining – fibre cement sheet.	Approx 26m ² Limited access	Asbestos detected	Good Sealed Non friable	Similar to original sample no. 6	Visible
SURVEY FINDINGS and HAZARD MANAGEMENT RECOMMENDATIONS					
Low Risk P4 – Avoid physical and mechanical damage. When maintenance/upgrade is required, recommend removal and reinstate with non-asbestos product.

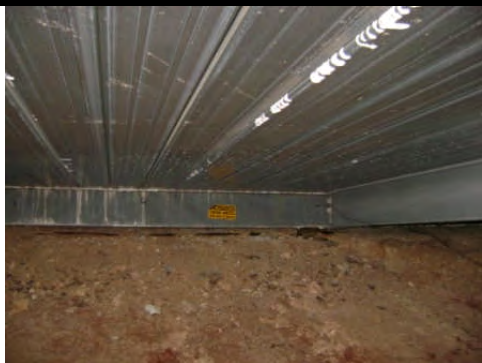
LOCATION - DESCRIPTION	EXTENT	ASBESTOS ASSESSMENT	CONDITION	SAMPLE NO VISUAL TEST	SIGNAGE STATUS
BASEMENT (UNDERGROUND VOID), Section 5.9 – 5.9.1. Retaining walls lining – fibre cement sheet. (Access via room G30)	Approx 50m ² Accessible	Asbestos detected	Not assessed	Similar to original sample no. 7	Visible
SURVEY FINDINGS and HAZARD MANAGEMENT RECOMMENDATIONS					
Low Risk P4 – Avoid physical and mechanical damage. When maintenance/upgrade is required, recommend removal and reinstate with non-asbestos product. August 2016/Sept 2017 - No access / confined space area. Access with caution.

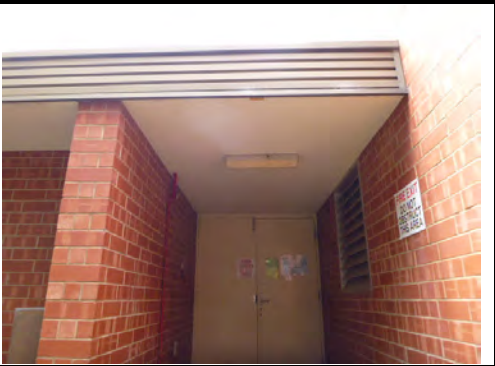
LOCATION - DESCRIPTION	EXTENT	ASBESTOS ASSESSMENT	CONDITION	SAMPLE NO VISUAL TEST	SIGNAGE STATUS	
ZWECK HOUSE (formally Clements House), Section 5.11 – 5.11.3. External, Western entrance porch lining – fibre cement sheet.	Approx 4m ² Limited access	Asbestos detected	Good Sealed Non friable	Similar to original sample no. 6	Visible

SURVEY FINDINGS and HAZARD MANAGEMENT RECOMMENDATIONS						
Low Risk P4 – Avoid physical and mechanical damage. When maintenance/upgrade is required, recommend removal and reinstate with non-asbestos product.

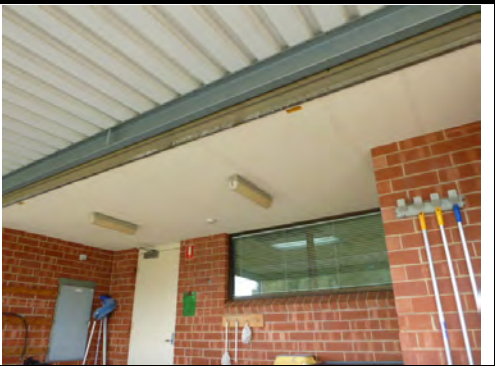
LOCATION - DESCRIPTION	EXTENT	ASBESTOS ASSESSMENT	CONDITION	SAMPLE NO VISUAL TEST	SIGNAGE STATUS	
ZWECK HOUSE (formally Clements House), Section 5.11 – 5.11.4. External, Kitchen entrance, western side, ceiling lining – fibre cement sheet.	Approx 4m ² Limited access	Asbestos detected	Good Sealed Non friable	Similar to original sample no. 6	Visible

SURVEY FINDINGS and HAZARD MANAGEMENT RECOMMENDATIONS						
Low Risk P4 – Avoid physical and mechanical damage. When maintenance/upgrade is required, recommend removal and reinstate with non-asbestos product.

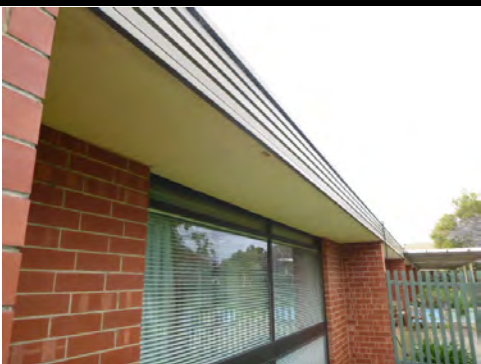
LOCATION - DESCRIPTION	EXTENT	ASBESTOS ASSESSMENT	CONDITION	SAMPLE NO VISUAL TEST	SIGNAGE STATUS	
ZWECK HOUSE (formally Clements House), Section 5.11 – 5.11.5. External, Western courtyard eaves lining – fibre cement sheet.	Approx 100m ² Limited access	Asbestos detected	Good Sealed Non friable	Similar to original sample no. 6	Visible

SURVEY FINDINGS and HAZARD MANAGEMENT RECOMMENDATIONS						
Low Risk P4 – Avoid physical and mechanical damage. When maintenance/upgrade is required, recommend removal and reinstate with non-asbestos product.

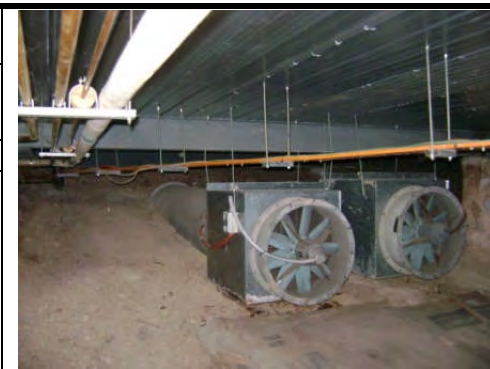
LOCATION - DESCRIPTION	EXTENT	ASBESTOS ASSESSMENT	CONDITION	SAMPLE NO VISUAL TEST	SIGNAGE STATUS
BASEMENT (UNDERGROUND VOID), Section 5.12 – 5.12.2. Air conditioner flange joints - mastic.	Every flange joint	Presume asbestos content	Not assessed	Original sample no. 9	Visible
SURVEY FINDINGS and HAZARD MANAGEMENT RECOMMENDATIONS					
Low Risk P4 – Recommend sample (x4) to qualify material content, otherwise treat item as asbestos containing. Avoid physical and mechanical damage. When maintenance/upgrade is required, recommend removal and reinstate with non-asbestos product. August 2016/Sept 2017 - No access / confined space area. Access with caution.

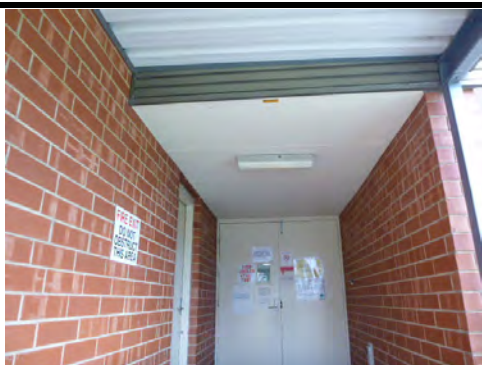
LOCATION - DESCRIPTION	EXTENT	ASBESTOS ASSESSMENT	CONDITION	SAMPLE NO VISUAL TEST	SIGNAGE STATUS
CLEMENTS HOUSE (formally Zweck House), Section 5.14 – 5.14.2. External, Western entrance porch lining – fibre cement sheet.	Approx 4m ² Limited access	Asbestos detected	Good Sealed Non friable	Similar to original sample no. 6	Visible
<i>SURVEY FINDINGS and HAZARD MANAGEMENT RECOMMENDATIONS</i>					
Low Risk P4 – Avoid physical and mechanical damage. When maintenance/upgrade is required, recommend removal and reinstate with non-asbestos product.

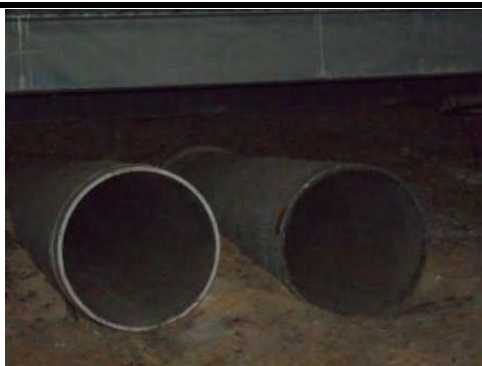
LOCATION - DESCRIPTION	EXTENT	ASBESTOS ASSESSMENT	CONDITION	SAMPLE NO VISUAL TEST	SIGNAGE STATUS
BASEMENT (UNDERGROUND VOID), Section 5.15 – 5.15.2. Basement vent pipes – formed cement pipes.	8 pipes, 400mm dia x 4m Accessible	Asbestos detected	Not assessed	Similar to original sample no. 8	Visible
<i>SURVEY FINDINGS and HAZARD MANAGEMENT RECOMMENDATIONS</i>					
Low Risk P4 – Avoid physical and mechanical damage. When maintenance/upgrade is required, recommend removal and reinstate with non-asbestos product. 2010 Notes - These pipes continue into the earth before surfacing as vents at ground level. August 2016/Sept 2017 - No access / confined space area. Access with caution.

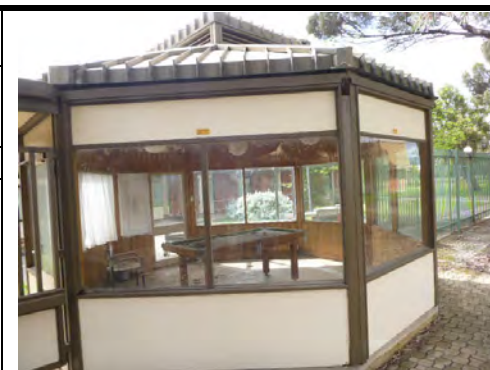
LOCATION - DESCRIPTION	EXTENT	ASBESTOS ASSESSMENT	CONDITION	SAMPLE NO VISUAL TEST	SIGNAGE STATUS
HOWARD HOUSE, Section 5.17 – 5.17.11. External, Solarium, upper infills – fibre cement sheet.	Approx 6m ² Limited access	Asbestos detected	Good Sealed Non friable	Similar to original sample no. 12	Visible
SURVEY FINDINGS and HAZARD MANAGEMENT RECOMMENDATIONS					
<p>Low Risk P4 – Avoid physical and mechanical damage. When maintenance/upgrade is required, recommend removal and reinstate with non-asbestos product.</p>

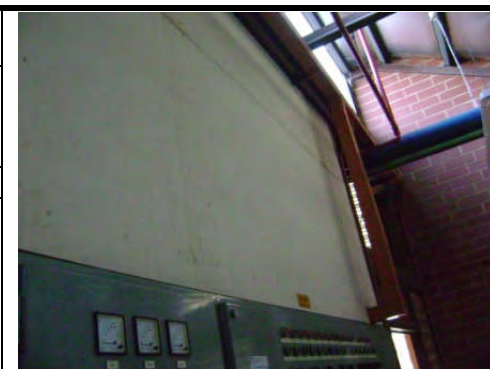
LOCATION - DESCRIPTION	EXTENT	ASBESTOS ASSESSMENT	CONDITION	SAMPLE NO VISUAL TEST	SIGNAGE STATUS
HOWARD HOUSE, Section 5.17 – 5.17.12. External, Main plant room (Rm G45), wall lining and upper infill above entry door – fibre cement sheet.	Approx 7m ² Limited access	Asbestos detected	Good Sealed Non friable	Similar to original sample no. 12	Visible
SURVEY FINDINGS and HAZARD MANAGEMENT RECOMMENDATIONS					
<p>Low Risk P4 – Avoid physical and mechanical damage. When maintenance/upgrade is required, recommend removal and reinstate with non-asbestos product.</p>

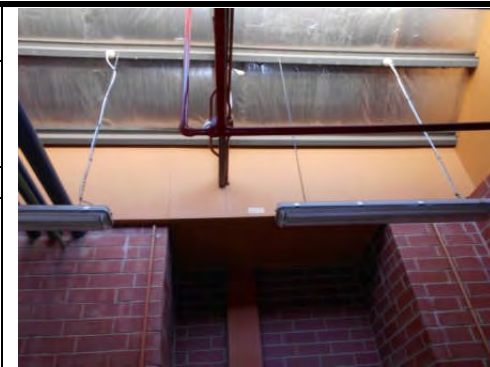
LOCATION - DESCRIPTION	EXTENT	ASBESTOS ASSESSMENT	CONDITION	SAMPLE NO VISUAL TEST	SIGNAGE STATUS
HOWARD HOUSE, Section 5.17 – 5.17.13. External / Internal, Boiler room (Rm G46), upper wall and ceiling lining including north and east sides lining – fibre cement sheet.	Approx 10m ² Limited access	Asbestos detected	Good Sealed Non friable	Similar to original sample no. 12	Visible
SURVEY FINDINGS and HAZARD MANAGEMENT RECOMMENDATIONS					
Low Risk P4 – Avoid physical and mechanical damage. When maintenance/upgrade is required, recommend removal and reinstate with non-asbestos product.

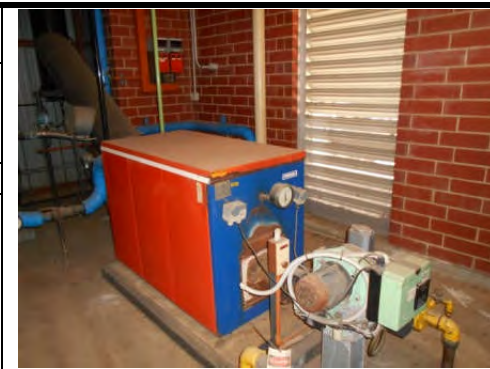
LOCATION - DESCRIPTION	EXTENT	ASBESTOS ASSESSMENT	CONDITION	SAMPLE NO VISUAL TEST	SIGNAGE STATUS
HOWARD HOUSE, Section 5.17 – 5.17.14. Internal, Boiler room, "Ferrol" boiler- Front blower gasket and other pipework gaskets and seals	Approx 300mm Inaccessible	Presume asbestos content	Not assessed	Visual	Visible
SURVEY FINDINGS and HAZARD MANAGEMENT RECOMMENDATIONS					
Low Risk P4 – Treat all gaskets (other than rubber or cork) as asbestos containing unless confirmed otherwise by sample analysis. Avoid physical and mechanical damage. When maintenance/upgrade is required, recommend removal and reinstate with non-asbestos product.					
August 2016/Sept 2017 - Boiler not dismantled for inspection. Assume asbestos within the unit unless confirmed otherwise. Access with caution.

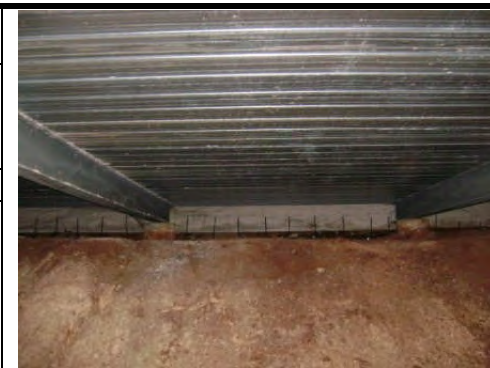
LOCATION - DESCRIPTION	EXTENT	ASBESTOS ASSESSMENT	CONDITION	SAMPLE NO VISUAL TEST	SIGNAGE STATUS
BASEMENT (UNDERGROUND VOID), Section 5.18 – 5.18.1. Retaining walls lining – fibre cement sheet.	Approx 50m ² Limited access	Asbestos detected	Not assessed	Similar to original sample no. 7	Visible
SURVEY FINDINGS and HAZARD MANAGEMENT RECOMMENDATIONS					
Low Risk P4 – Avoid physical and mechanical damage. When maintenance/upgrade is required, recommend removal and reinstate with non-asbestos product.					
August 2016/Sept 2017 - No access / confined space area. Access with caution.

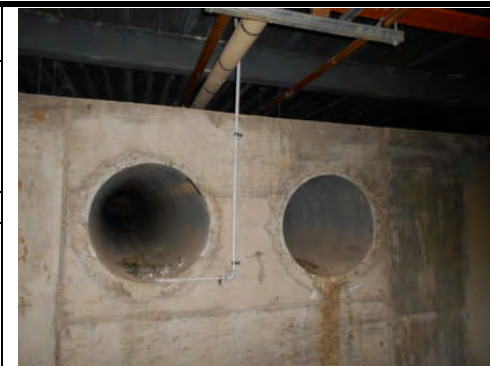
LOCATION - DESCRIPTION	EXTENT	ASBESTOS ASSESSMENT	CONDITION	SAMPLE NO VISUAL TEST	SIGNAGE STATUS
5.18.2. Basement vent pipes – formed cement pipes. (Access via plant room)	5 pipes, 400mm dia x 4m visible Limited access	Asbestos detected	Not assessed	Similar to original sample no. 8	Visible
SURVEY FINDINGS and HAZARD MANAGEMENT RECOMMENDATIONS					
<p>Low Risk P4 – Avoid physical and mechanical damage. When maintenance/upgrade is required, recommend removal and reinstate with non-asbestos product.</p> <p>2010 Notes - These pipes continue into the earth before surfacing as vents at ground level.</p> <p>August 2016/Sept 2017 - No access / confined space area. Access with caution.</p>

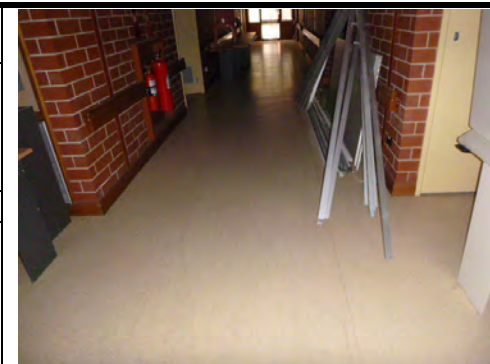
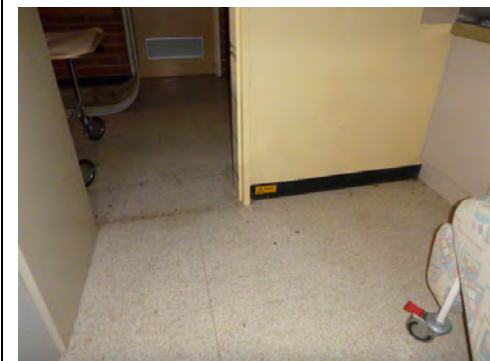
LOCATION - DESCRIPTION	EXTENT	ASBESTOS ASSESSMENT	CONDITION	SAMPLE NO VISUAL TEST	SIGNAGE STATUS
HOWARD HOUSE, Section 5.19 (PART A) – 5.19.1. Internal, Flooring throughout – vinyl floor covering with asbestos backing material. Note; southern and eastern areas are restricted access / unoccupied.	Not quantified Limited access	Asbestos detected	Moderate Unsealed Friable	Similar to original sample no. 14	Visible
SURVEY FINDINGS and HAZARD MANAGEMENT RECOMMENDATIONS					
<p>Medium Risk P3 – Multi areas damaged. Recommend make safe in accordance with “Asbestos Approved Code of Practice”. Backing layer trapped under vinyl. Item regarded safe whilst vinyl remains in good condition to protect from and prevent disturbance of asbestos backing layer. Note - as required by the OHS&W regulations, removal of this type of material is required to be performed by a licensed removalist.</p> <p>2010 Notes - Some areas covered by carpets, limited inspection.</p> <p>2013: 18/19 May 318m² Vinyl sheet removed from Howard House. Areas: Large Group room, T/L office, G11, 12, 22, 23, 21, 20, 19, 16 & Williams Day Centre. Note that vinyl sheet remains under central cupboards and partition walls. Access with caution.</p> <p>Sept 2017 – Notes per above, Access with caution.</p>

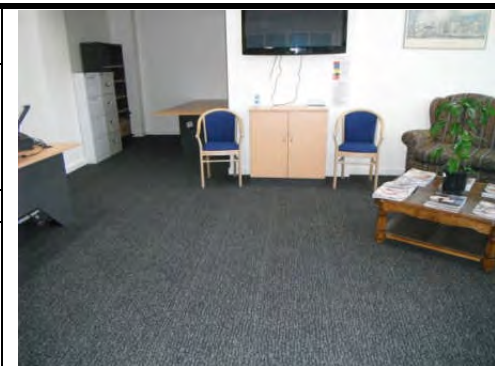
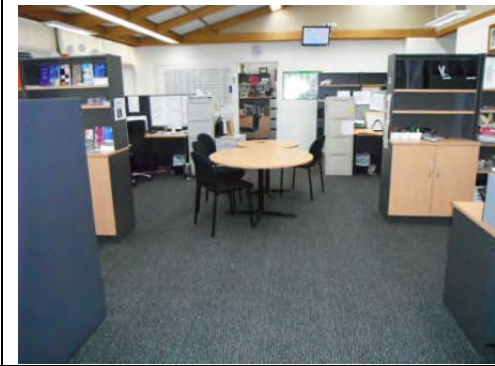
LOCATION - DESCRIPTION	EXTENT	ASBESTOS ASSESSMENT	CONDITION	SAMPLE NO VISUAL TEST	SIGNAGE STATUS
HOWARD HOUSE, Section 5.19 (PART B) – 5.19.1. Internal. Williams Day Care Centre / inaccessible areas under cupboards and inner partition walls – vinyl floor covering with asbestos backing material.	Not quantified Inaccessible	Asbestos detected	Not assessed (Friable)	Similar to original sample no. 14	Visible
<i>SURVEY FINDINGS and HAZARD MANAGEMENT RECOMMENDATIONS</i>					
<p>Low Risk P4 – Note that vinyl sheet remains under central cupboards and partition walls. Access with caution.</p> <p>2013: 18/19 May 318m² Vinyl sheet removed from Howard House. Northern Areas: <u>Large Group room</u>, T/L office, G11, 12, 22, 23, 21, 20, 19, 16 & <u>Williams Day Centre</u>.</p> <p>Sept 2017 – Notes per above, Access with caution.</p>

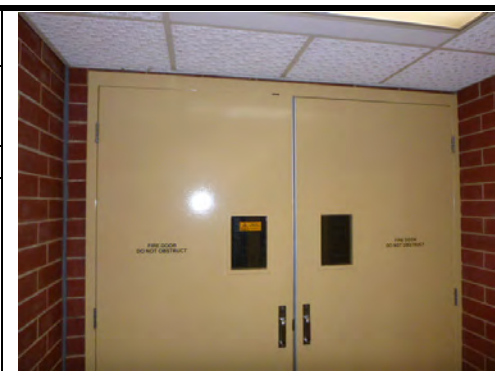
LOCATION - DESCRIPTION	EXTENT	ASBESTOS ASSESSMENT	CONDITION	SAMPLE NO VISUAL TEST	SIGNAGE STATUS
HOWARD HOUSE, Section 5.19 – 5.19.2. Internal, Corridor fire doors - adjacent Room G6 - internal core.	Approx 4m ² Limited access	Asbestos detected	Good Sealed Friable	Similar to original sample no. 11	Visible
<i>SURVEY FINDINGS and HAZARD MANAGEMENT RECOMMENDATIONS</i>					
<p>Low Risk P4 – Avoid physical and mechanical damage. When maintenance/upgrade is required, recommend removal and reinstate with non-asbestos product.</p> <p>August 2016 - Treat all fire doors as having an asbestos internal core unless confirmed otherwise by sample analysis.</p>

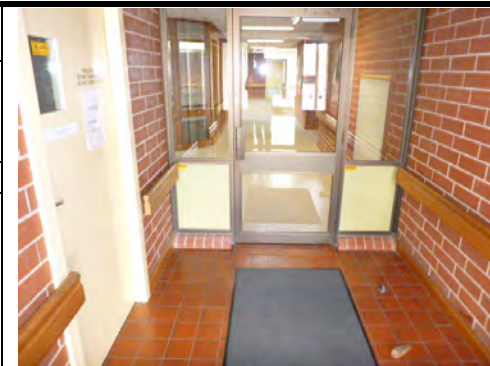
LOCATION - DESCRIPTION	EXTENT	ASBESTOS ASSESSMENT	CONDITION	SAMPLE NO VISUAL TEST	SIGNAGE STATUS
HOWARD HOUSE, Additional item 2016 Internal, Western entrance / opposite room G44, infill panels below windows / either side of door – fibre cement sheet.	Approx 1m ² Accessible	Presume asbestos content	Good Sealed Non friable	Visual	Visible
SURVEY FINDINGS and HAZARD MANAGEMENT RECOMMENDATIONS					
Low Risk P4 – Avoid physical and mechanical damage. When maintenance/upgrade is required, recommend removal and reinstate with non-asbestos product.

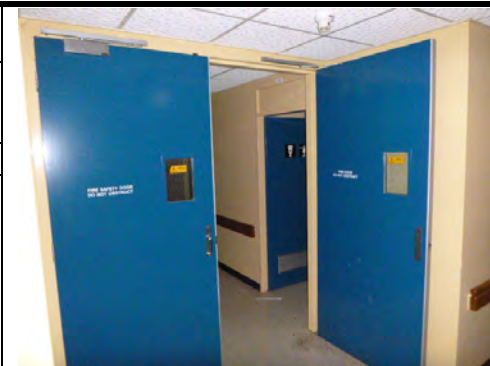
LOCATION - DESCRIPTION	EXTENT	ASBESTOS ASSESSMENT	CONDITION	SAMPLE NO VISUAL TEST	SIGNAGE STATUS
HOWARD HOUSE, Section 5.19 – 5.19.6. Internal, Corridor fire door -adjacent Room G92 - internal core.	Approx 4m ² Limited access	Asbestos detected	Good Sealed Friable	Similar to original sample no. 11	Visible
SURVEY FINDINGS and HAZARD MANAGEMENT RECOMMENDATIONS					
Low Risk P4 – Avoid physical and mechanical damage. When maintenance/upgrade is required, recommend removal and reinstate with non-asbestos product.					
August 2016 - Treat all fire doors as having an asbestos internal core unless confirmed otherwise by sample analysis.

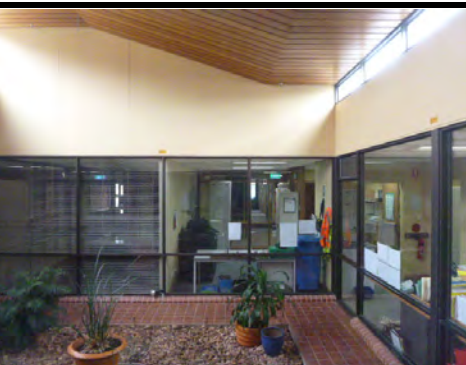
LOCATION - DESCRIPTION	EXTENT	ASBESTOS ASSESSMENT	CONDITION	SAMPLE NO VISUAL TEST	SIGNAGE STATUS
HOWARD HOUSE, Section 5.19 – 5.19.11. Internal / External, Light court (area behind Admin Office), vent pipes (x2) – formed cement pipe.	2 pipes, Approx 500mm dia. Accessible	Asbestos detected	Good Sealed Non friable	Similar to original sample no. 8	Visible
SURVEY FINDINGS and HAZARD MANAGEMENT RECOMMENDATIONS					
Low Risk P4 – Avoid physical and mechanical damage. When maintenance/upgrade is required, recommend removal and reinstate with non-asbestos product. 2010 Notes - Item extends through ground and tunnels below.
