Locality Map - Hillcrest Hospital

Photographic Record of Site Inspection

Site Plans Showing Potentially Contaminated Areas and Other Potential Liabilities

Site Plan Showing Location of Trial Excavation Area

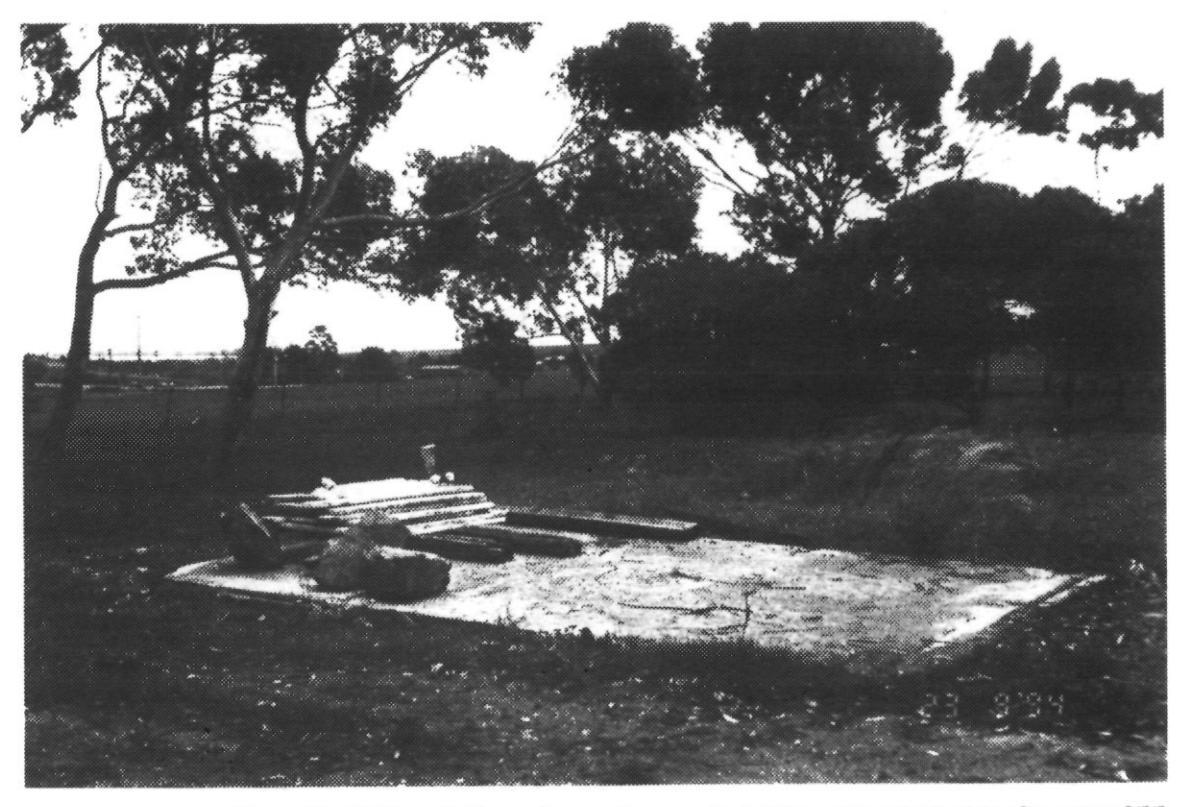
Photo 18: Waste heap north of carpark on section 855

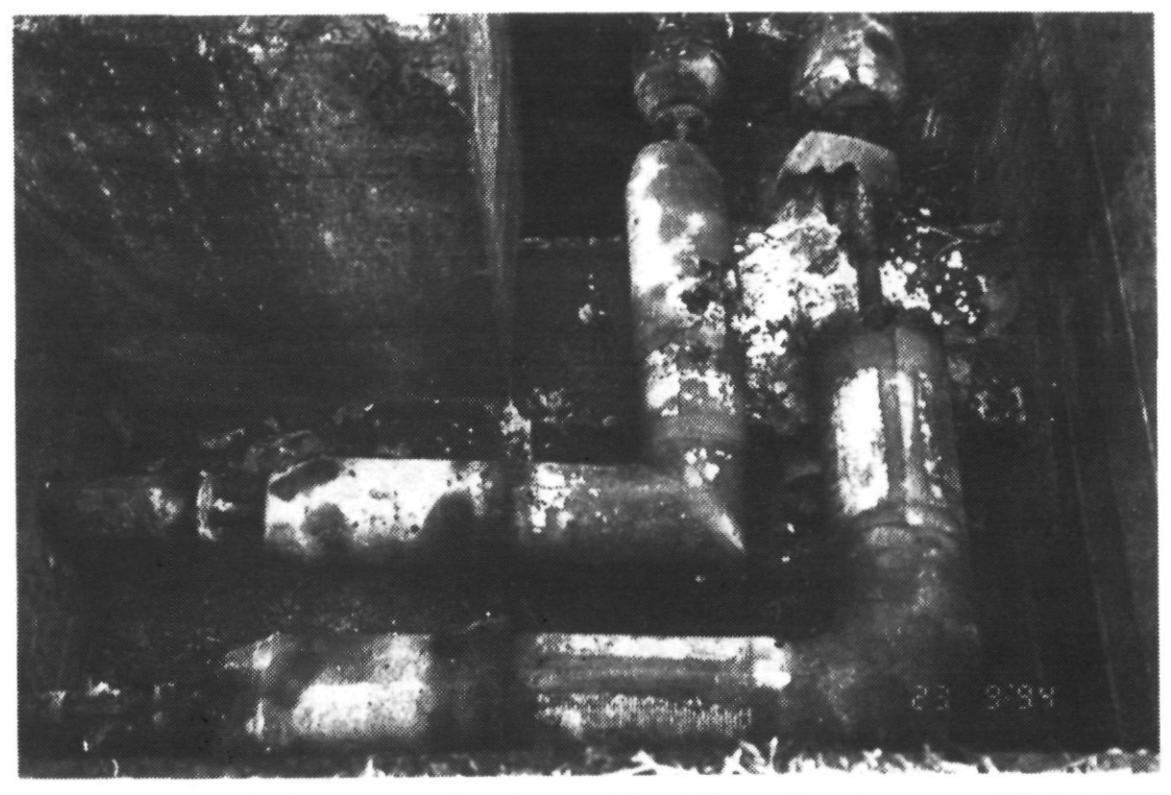
Photo 20: Redundant underground steam and condensate piping between Anderson House (Ward 5) and Howard House (Ward 10). Deteriorated outer pipe casings reveal possible asbestos insulation

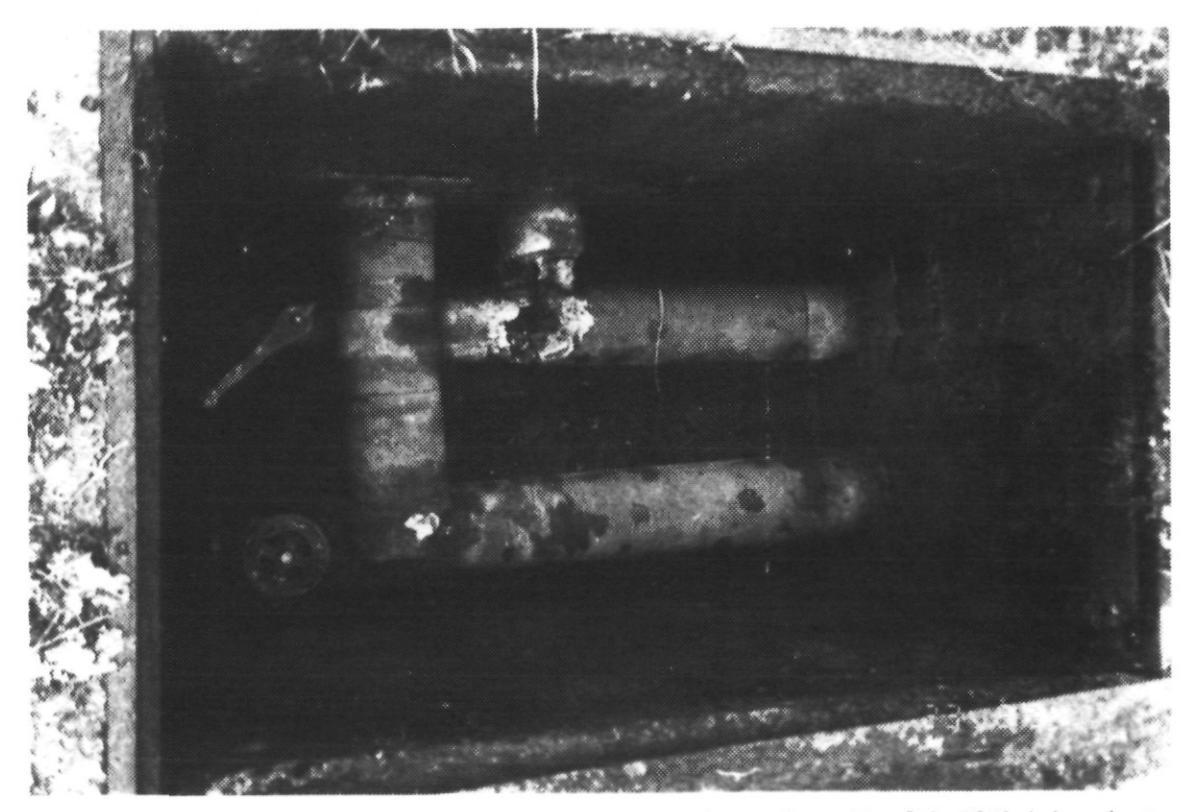
Photo 21: Redundant steam and condensate piping at the south western corner of the industrial Therapy (IT) Workshop. Deteriorated outer pipe casings reveal possible asbestos insulation

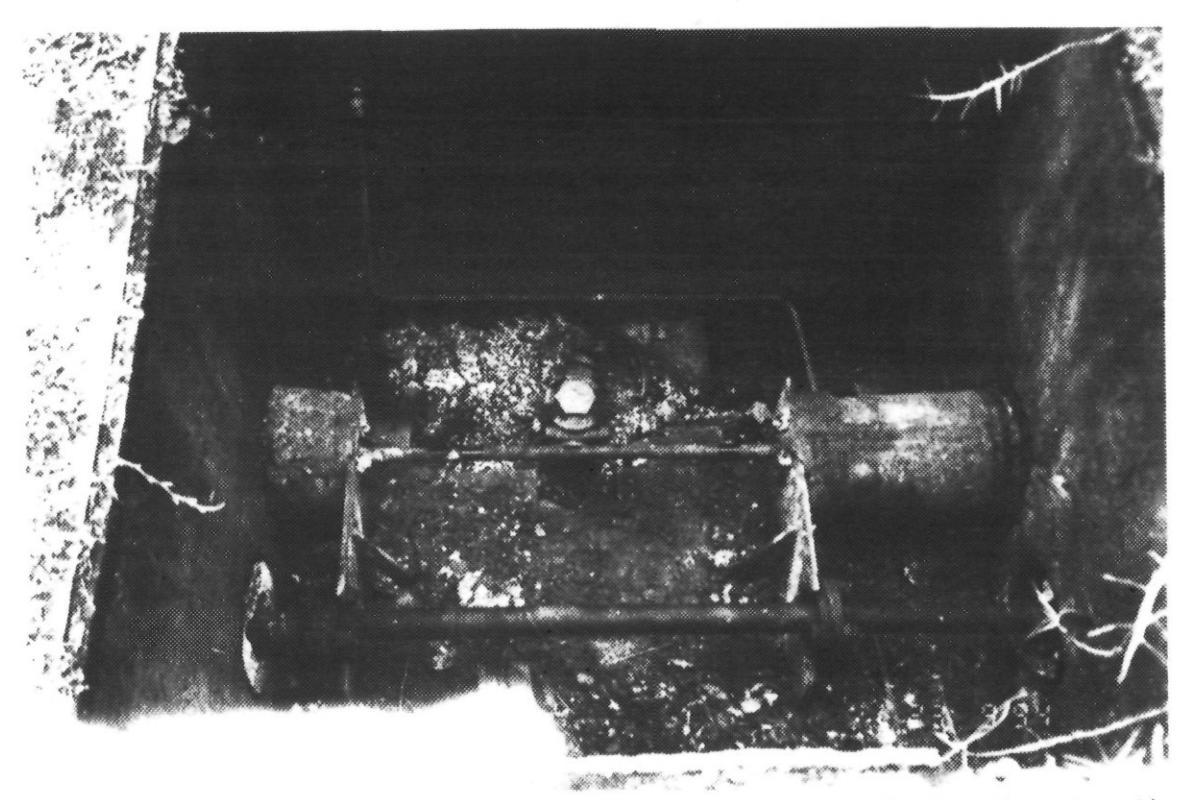
Photo 22: Redundant steam and condensate piping at the southern side of the IT Workshop. Again, deteriorated outer pipe casings reveal possible asbestos insulation

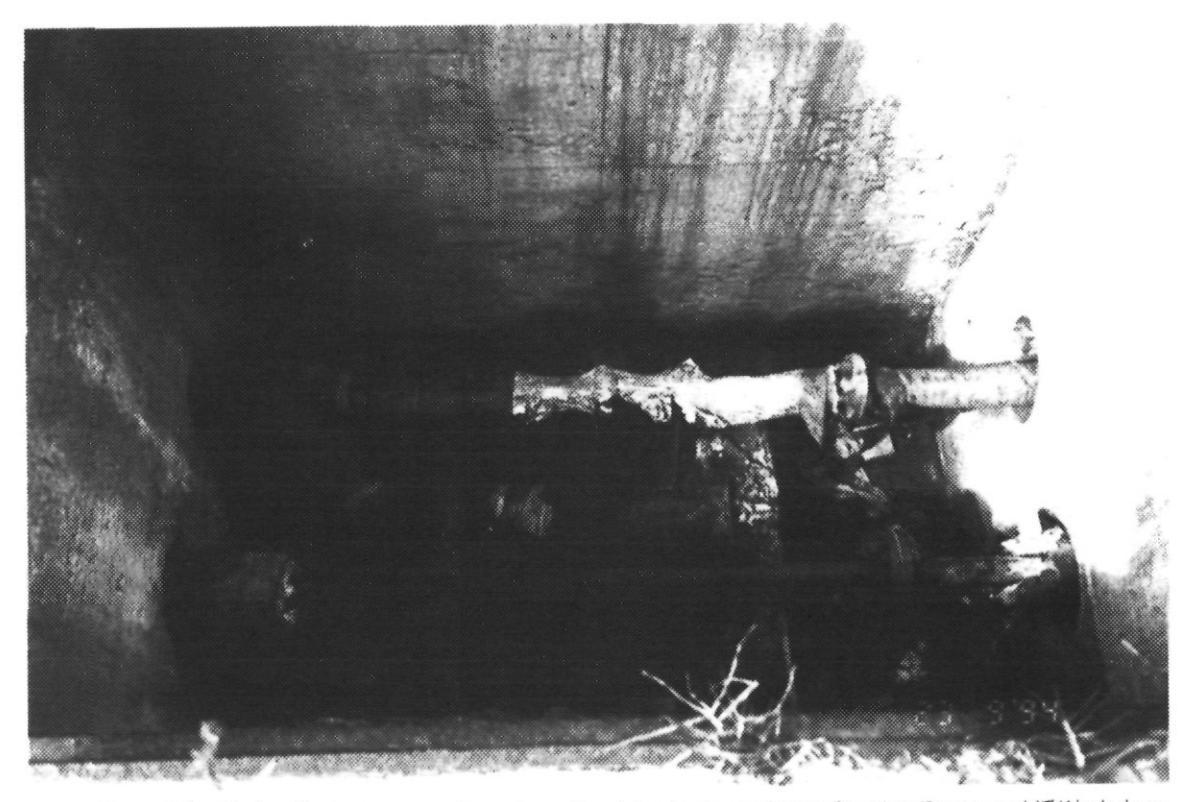
Photo 23: Redundant steam and condensate piping between two expansion bends on the eastern side of the IT Workshop. Scattered debris from outer pipe casing may contain asbestos

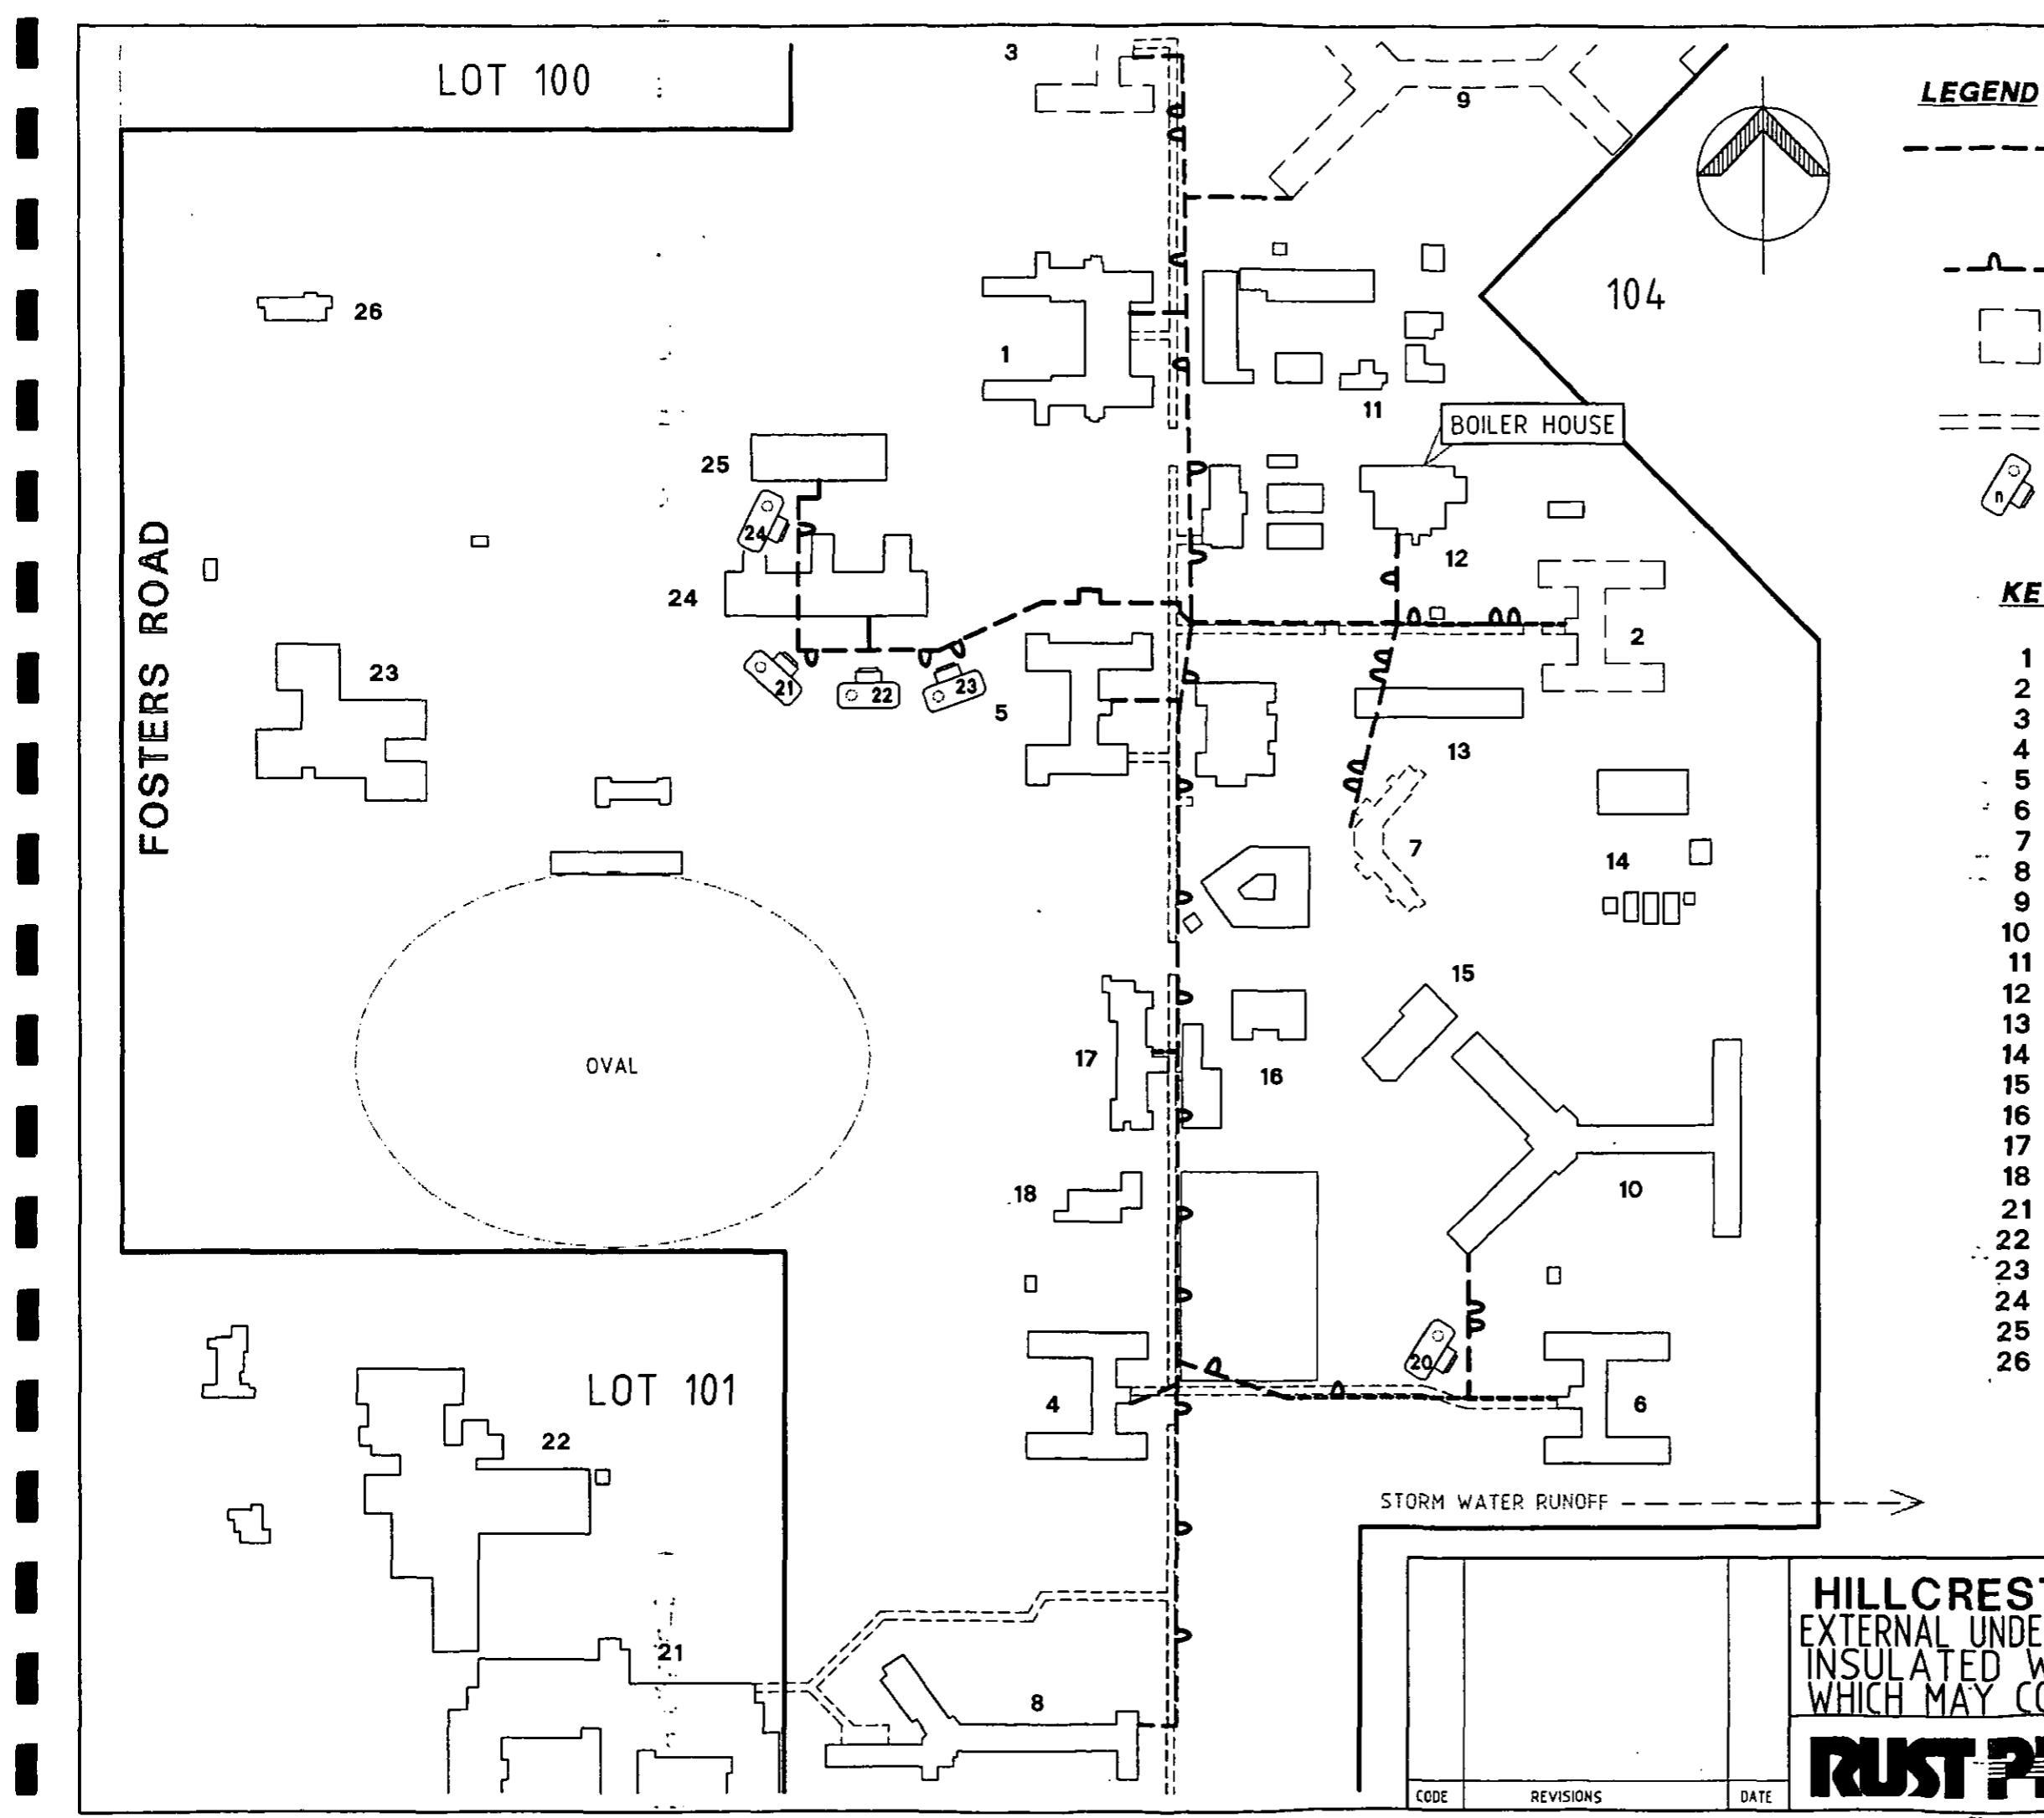
POSSIBLE LOCATION OF ASBESTOS CLAD PIPING. (STEAM & CONDENSATE PIPES RUN PARALLEL)
	EXPANSION BEND
] ]	DEMOLISHED BUILDING
_	COVERED WALKWAY
Z	PHOTGRAPH LOCATION AND NUMBER

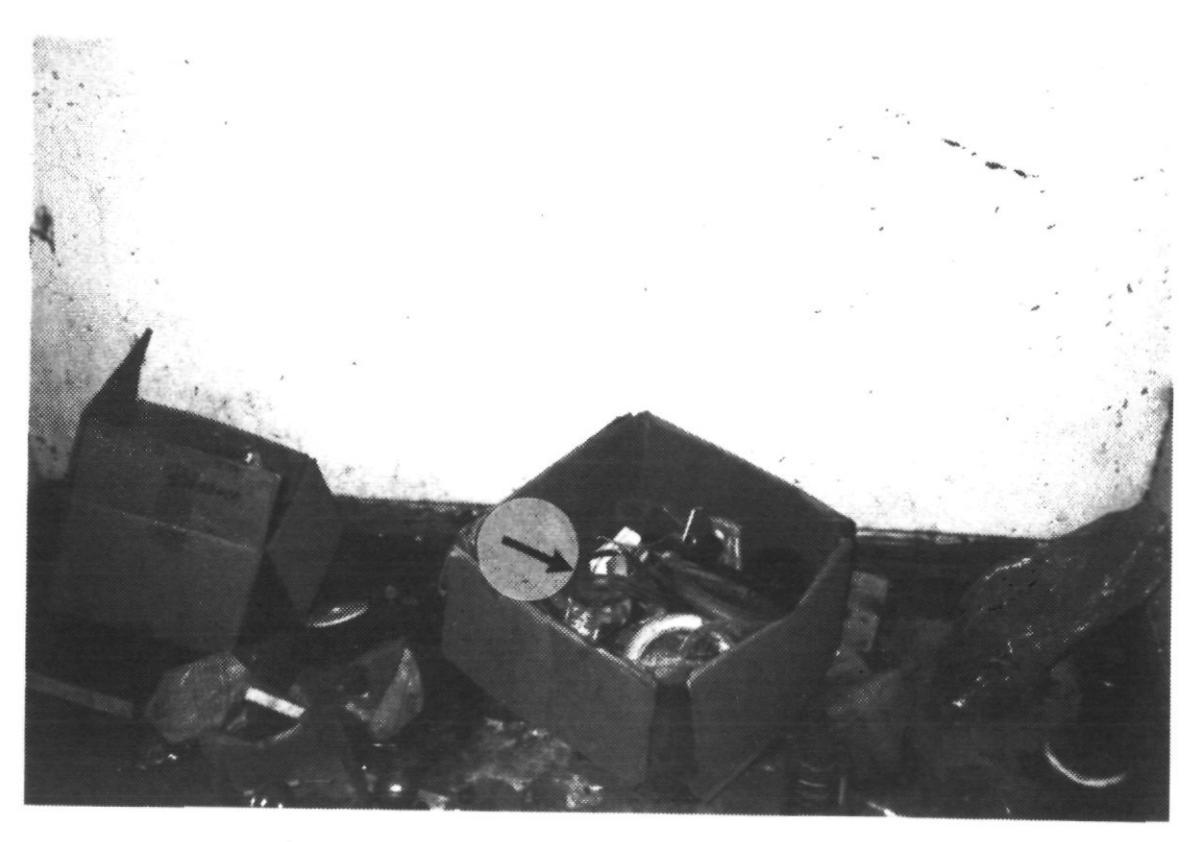
Photo 5: Building 17 (Boiler House). Disused asbestos clad pipework.

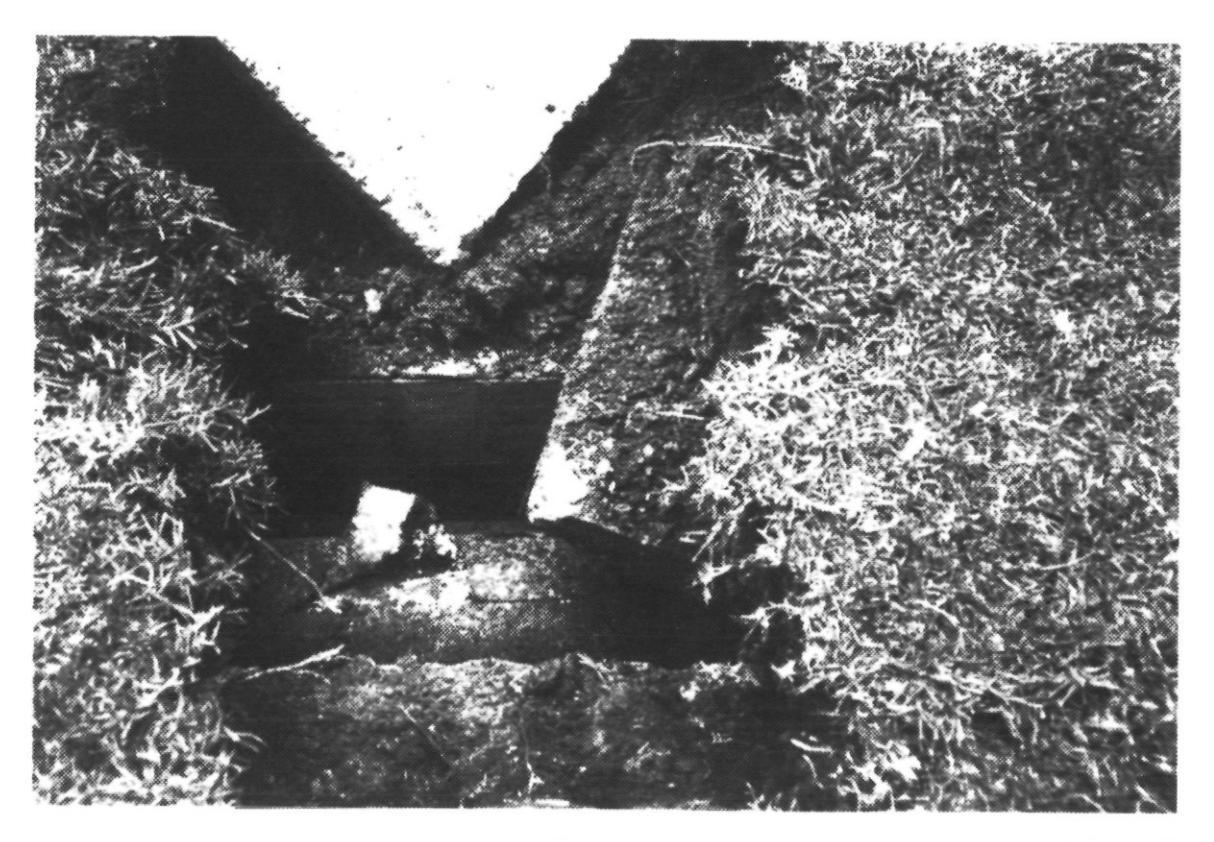
Photo 7: Excavation 2 - Asbestos clad concrete encased pipework.

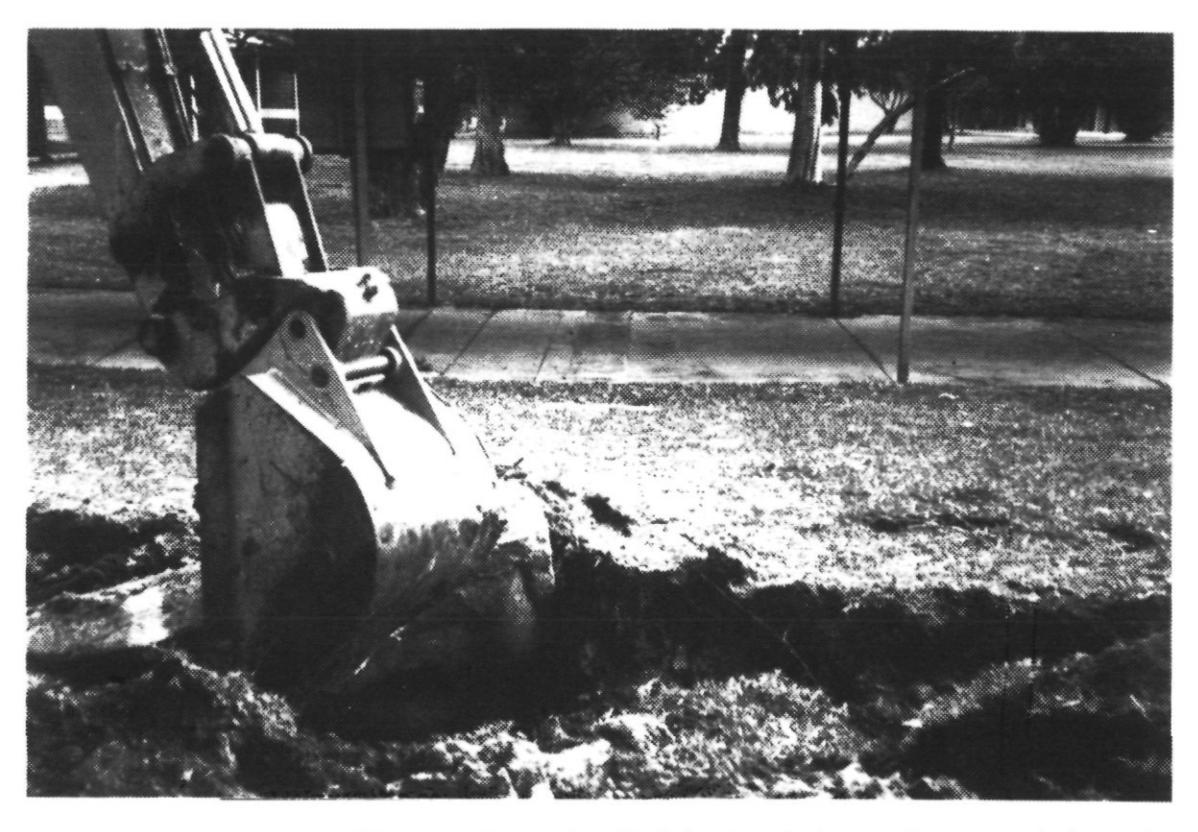
Photo 8: Excavation 3 - SMF (non-asbestos) lagged pipework

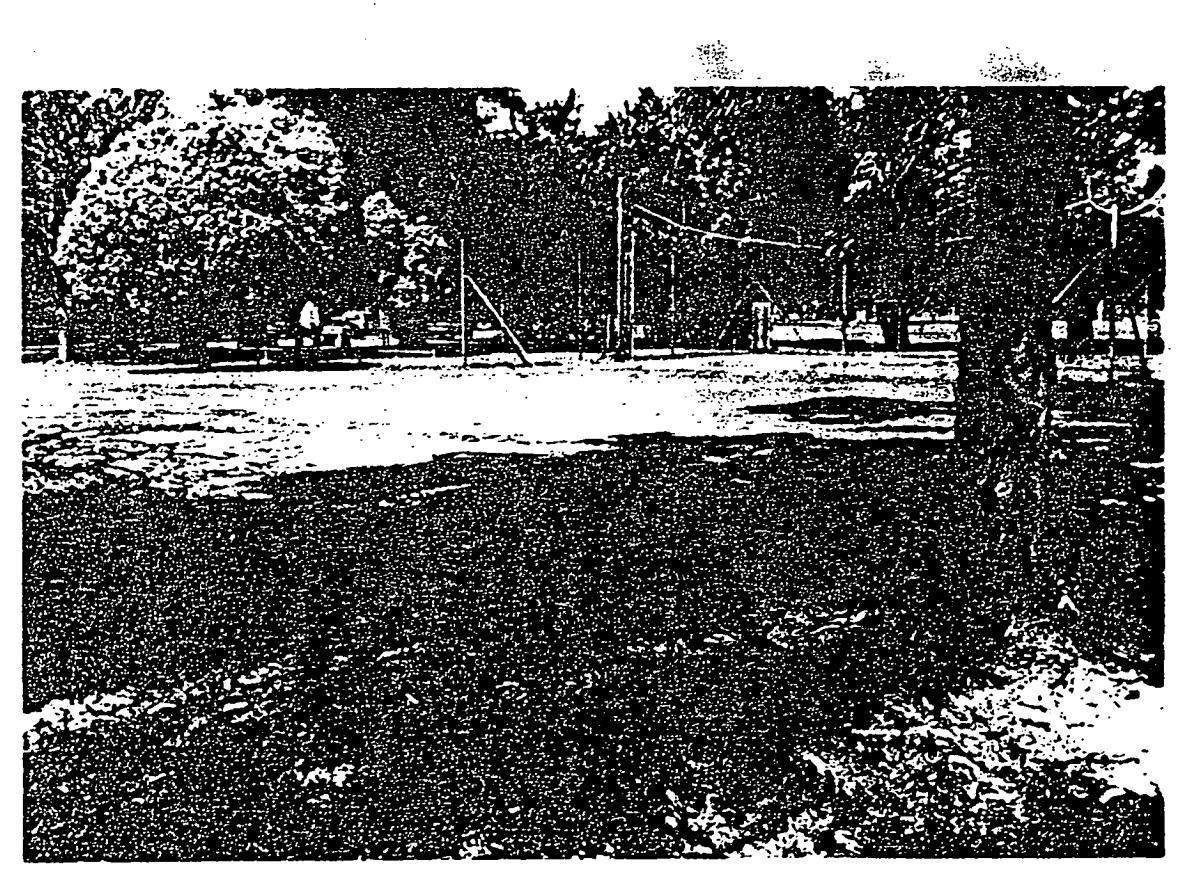
Photo 1: "Square Acre" (looking west towards the chapel and Ward 4) is possibly landscaped with coke ash

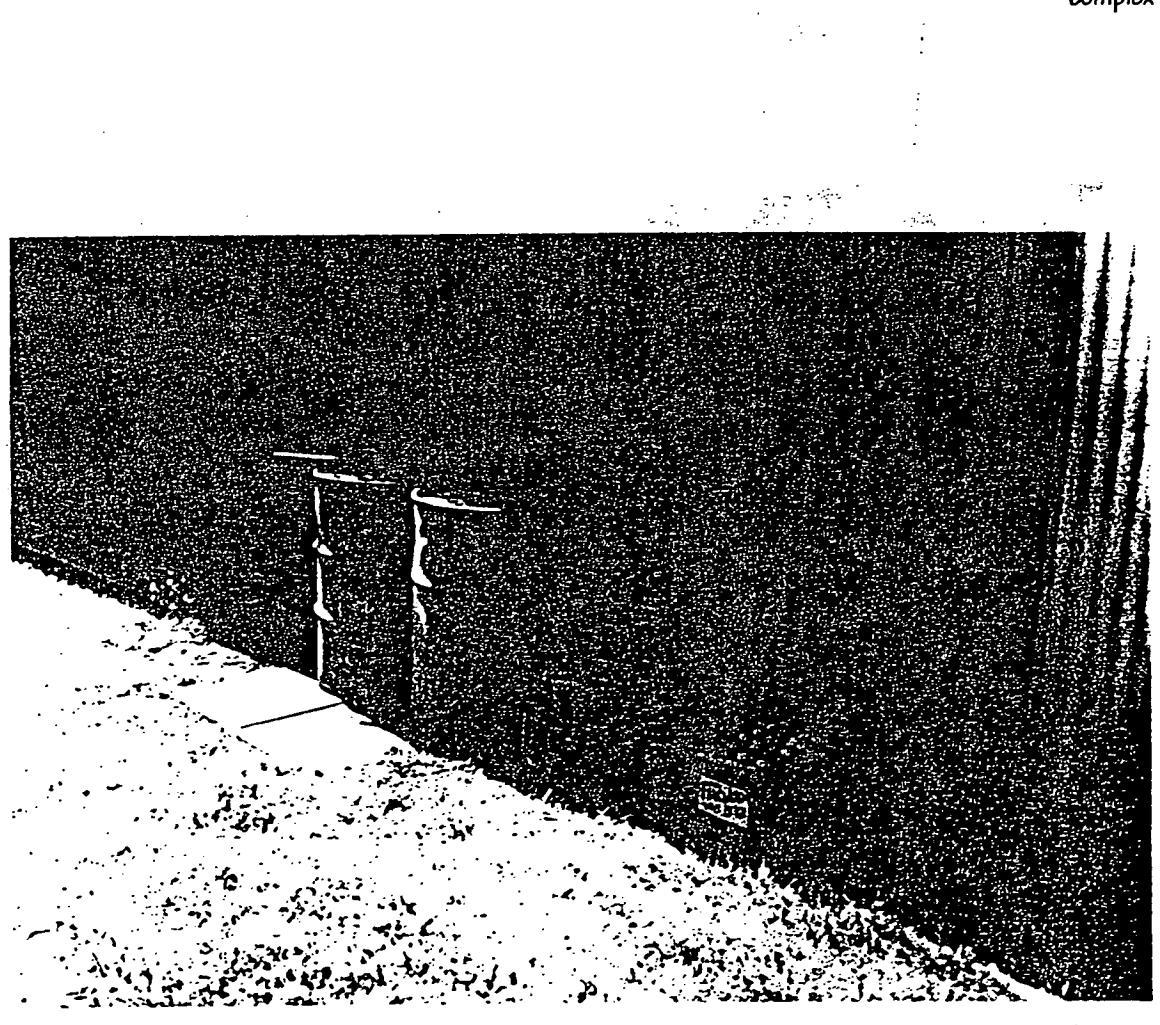
Photo 5: Diesel bowser and underground fuel storage tank on the eastern side of the Garage/Garden complex

Attached is our Site Assessment Report for your action. It recommends the removal of the underground fuel storage tanks and the underground pipe work. In addition, further general testing of the site is recommended especially areas of building rubble and unknown fill.

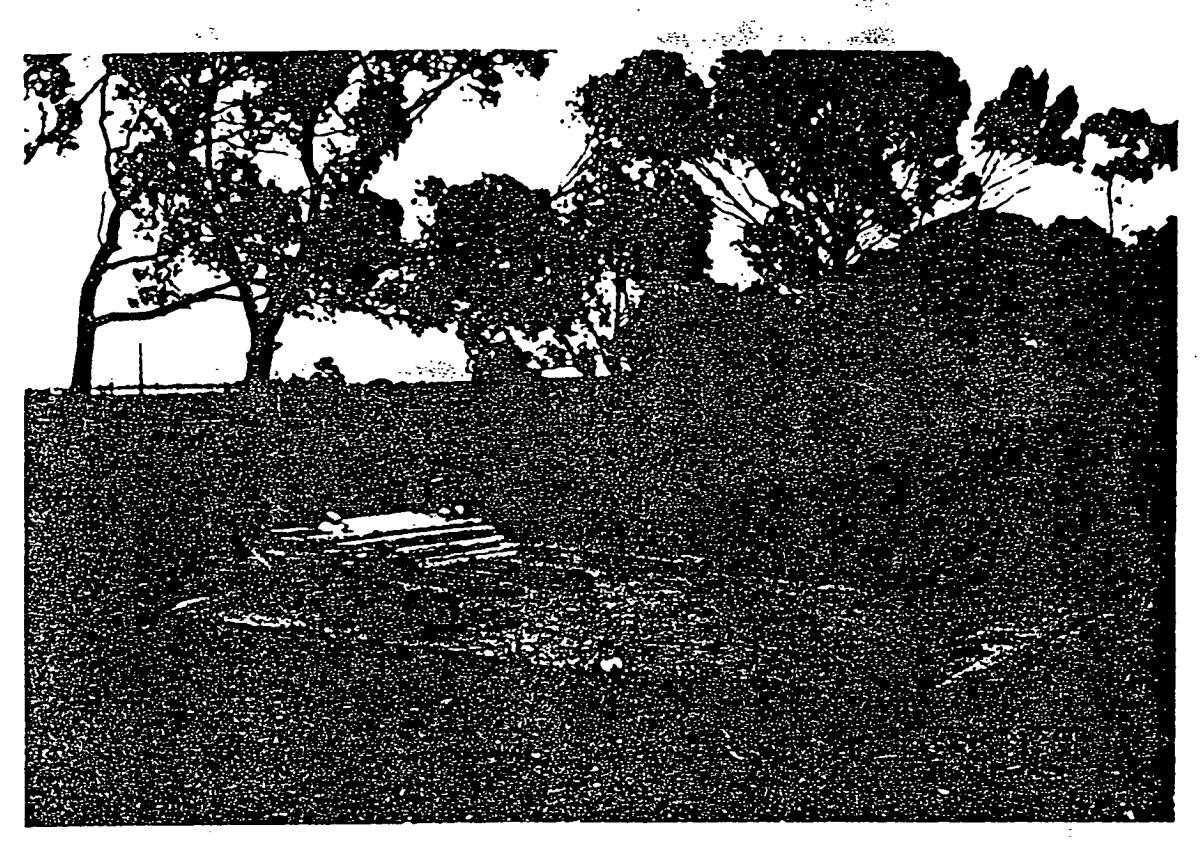
Photo 18: Waste heap north of carpark on section 855
