# TREE ASSESSMENT

S22675 Renewal Sa Gilles Plains Tafe Site

Wednesday, 17 April 2019

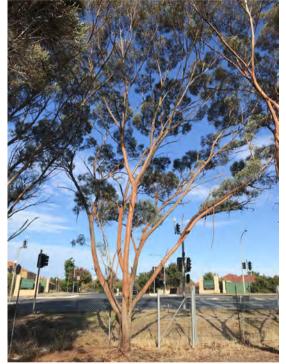
Tree In Good Health Shape And Form. Worthy Of Retaining.

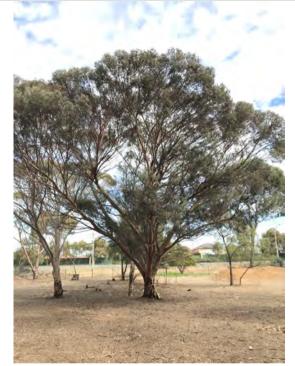
Tree Shows Good Health And Structure. Bifurcated At 1m Forming Co Dominant Stems. Good Union. Girdle Root At Base. Worthy Of Retaining.

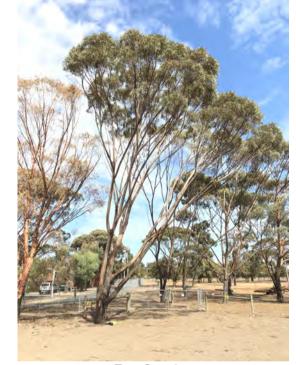
Large Gum In Sheep Paddock. Major Cambium Damage From Live Stock. Good Health.

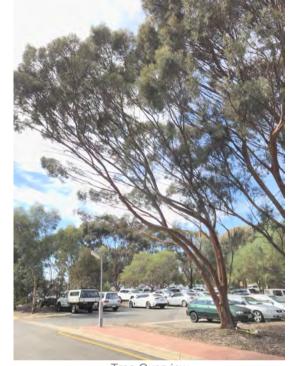
Good Health Shape And Form. Bias To West.

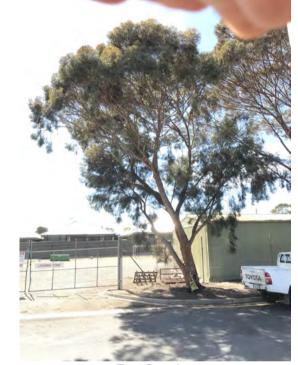
Good Health Shape And Form. Good Occlusion To Trunk Wound. Some Termite Frass Visible On Wound. Worthy Of Retaining.

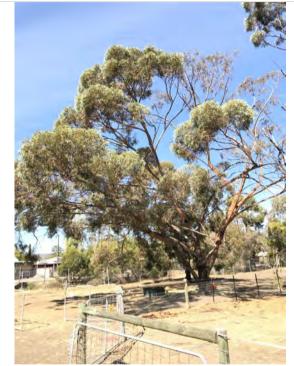
Tree Located In Horse Area. Tree Showing Reasonable Health With Cambium Damage Around Trunk Section. Wound From Large Limb Fail. No Work.

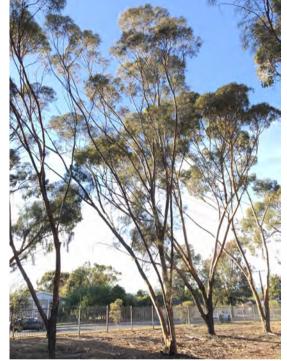
Large Gum With Good Health. Canopy Bias To North. Included Bark In Main Trunk Bifurcation. Appears Stable.

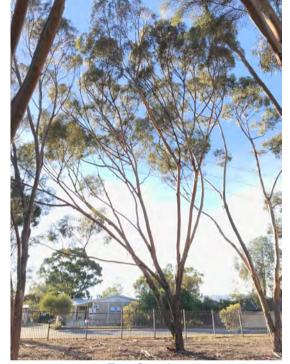
Good Health And Reasonable Form. Tree Worth Retaining If Kept Inline With Neighbouring Gums.

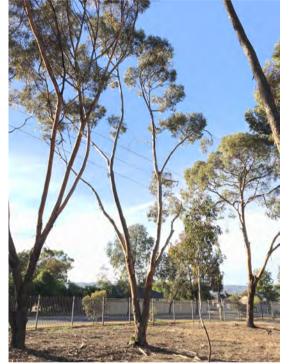
Large Gum On Eastern Fence Line. Shows Good Health. Worthy Of Retaining.

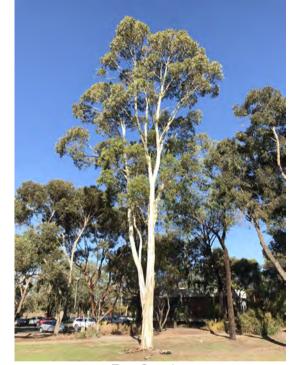
Good Health And Form. Requires Deadwood Pruning In Canopy.

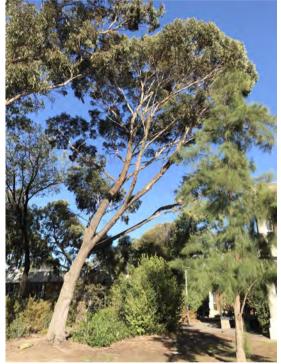
Large Sa Blue Gum With Goos Structure Shape And Form. Showing Good Canopy Health. Minor Deadwood To Prune From Tree. Worthy Of Retaining.

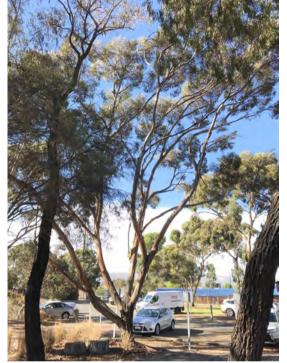
Large Gum With Good Health And Structure.
